Détection de l'endommagement dans un composite tissé PA66,6/Fibres de verre à l'aide de techniques ultrasonores en vue d'une prédiction de la durabilité de pièces automobiles

T H È S E

Pascal POMAREDE

Damage detection in PA 66/6|Glass woven fabric composite material using ultrasonic techniques towards durability prediction of automotive parts

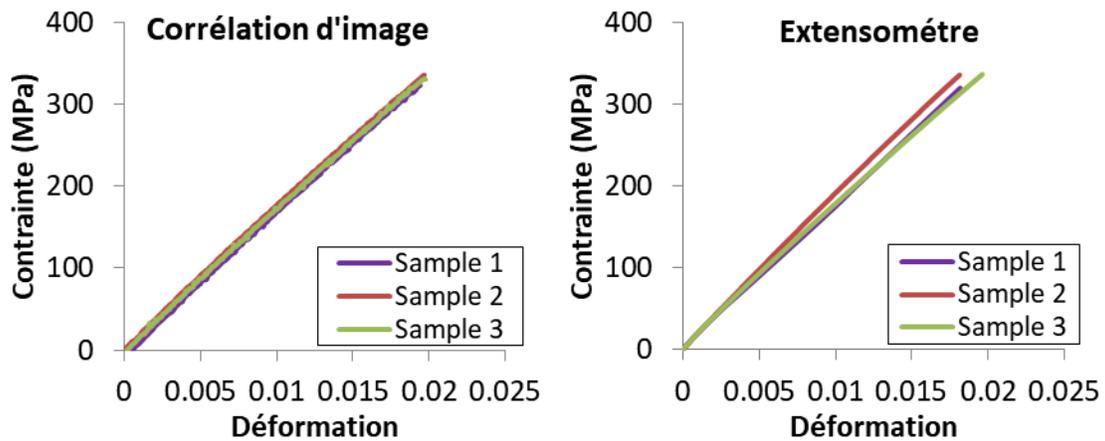
Figure 4 : Réponses contrainte/déformation obtenues par corrélation d'image (Gauche) et extensomètre (Droite) sur trois échantillons dans la configuration 0°.

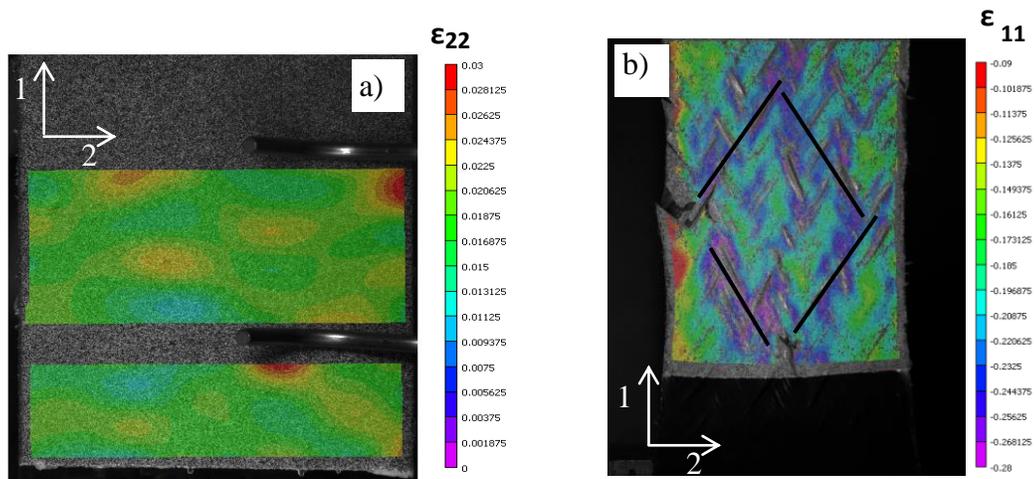
Figure 6 : (a) Champs de déformation ϵ_{11} pour un échantillon dans la configuration 0° . (b) Champs de déformation ϵ_{22} pour un échantillon dans la configuration 45° . Les deux champs sont calculés peu avant la ruine.

A l'aide des résultats de corrélation d'image, les champs de déformation dans le plan du composite ont pu être mesurés pour les deux configurations d'échantillons. En observant le champ ϵ_{11} (avec « 1 » la direction de chargement) juste avant la ruine de l'échantillon sur la Figure 6-a, on peut remarquer que celui-ci reste relativement homogène pour la configuration 0°. Les champs de déformation ϵ_{22} et ϵ_{12} n'évoluent presque pas. En revanche, pour la configuration 45°, tous les champs du plan évoluent de façon significative. Des efforts de cisaillement sont clairement induits sur la partie centrale de l'éprouvette. Cette zone correspond à la zone en forme de losange visible sur la Figure 6-b. Dans cette zone, les fibres vont avoir tendance à se réorienter suivant la direction de chargement. On peut remarquer des zones avec des craquelures où le calcul de corrélation ne s'est pas fait correctement. Ces craquelures apparaissent généralement lorsque l'angle de déformation maximal a été localement atteint. Cet angle dépend notamment du motif de tissage utilisé et permet d'obtenir des informations sur les propriétés de cisaillement dans le plan du composite. Une étude relativement complète de ces essais, permettant l'extraction des propriétés de cisaillement des composites tissés, a été réalisée par Boisse et al. [4].

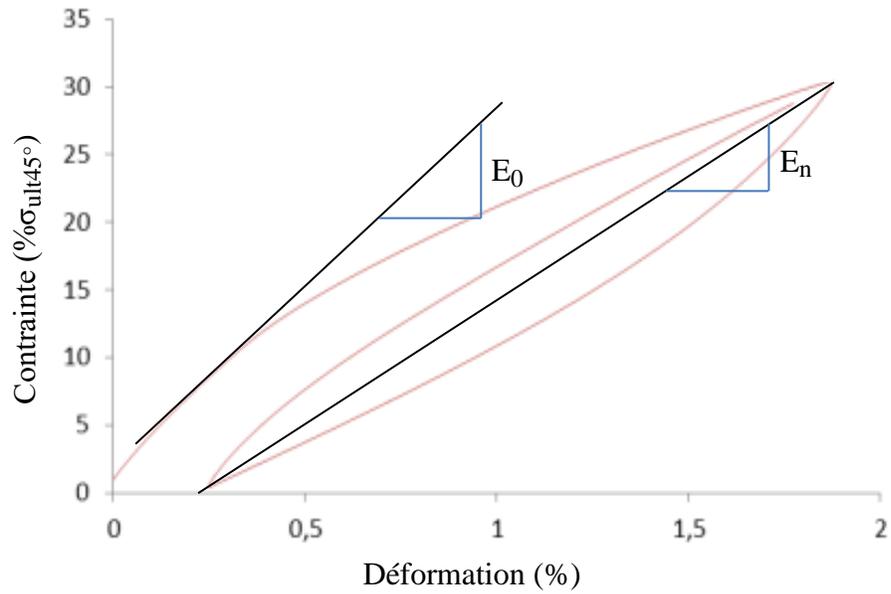
Figure 7 : Mesure des modules E_0 et E_n sur une courbe charge/décharge.

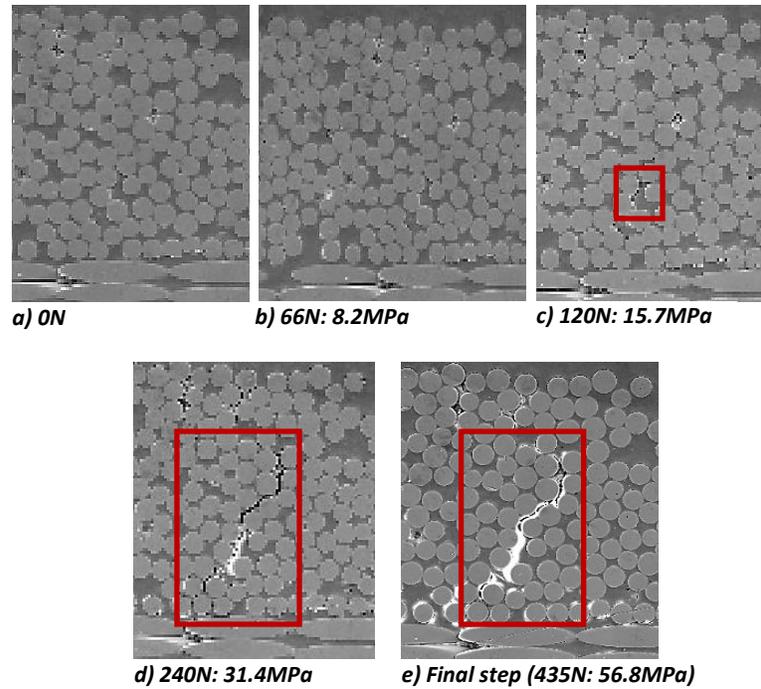
Figure 9: Images MEB lors d'essais de traction in-situ pour différents niveaux de changements appliqués suivant l'axe des fibres

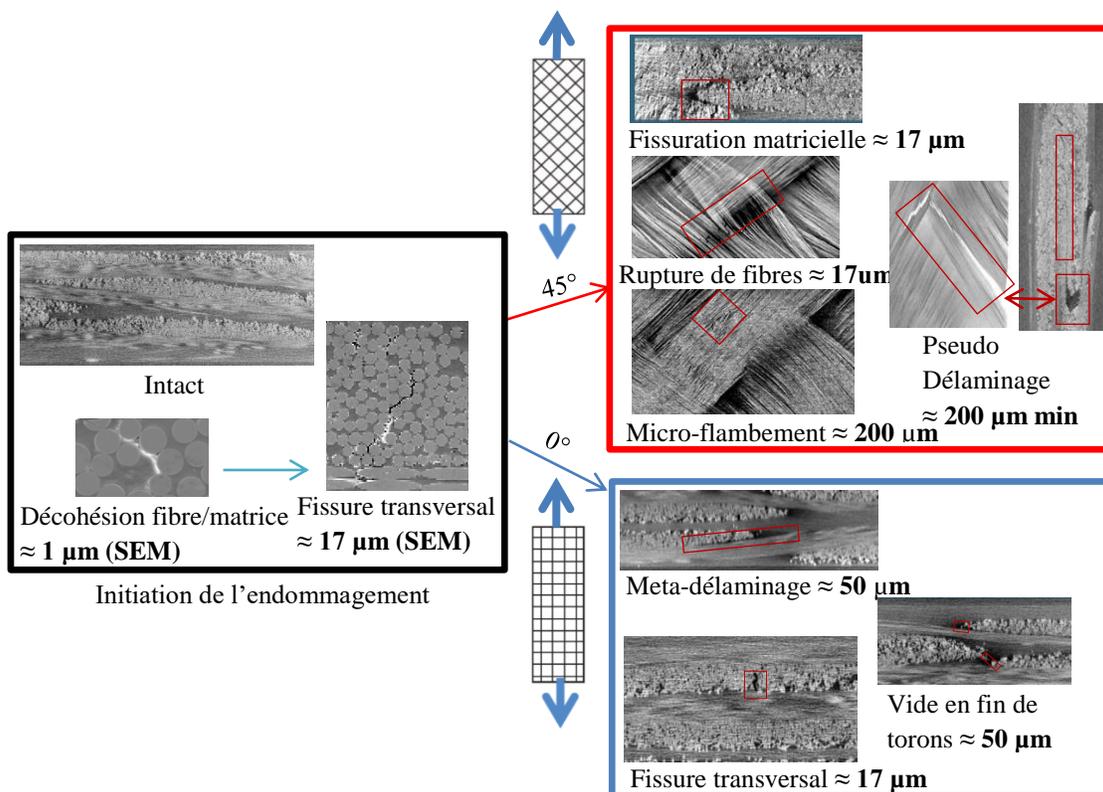
Figure 11 : Récapitulatif des mécanismes d'endommagement et leurs tailles caractéristiques associées pour les échantillons dans la configuration 0° and 45°

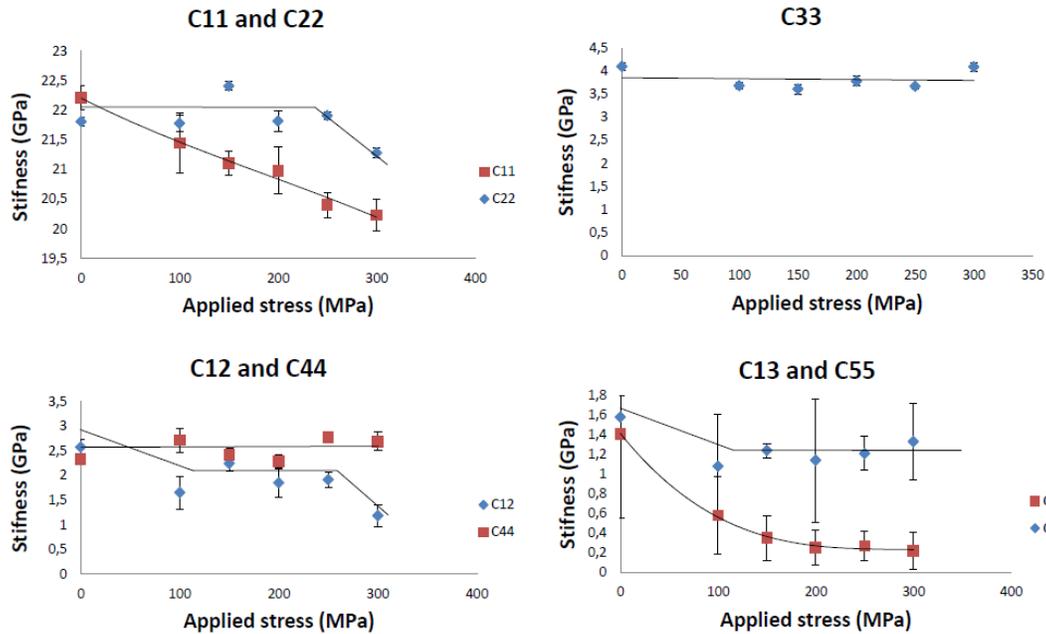
Figure 15 : Evolution de sept des constantes de rigidité en fonction du chargement, pour différents échantillons orientés à 0°.

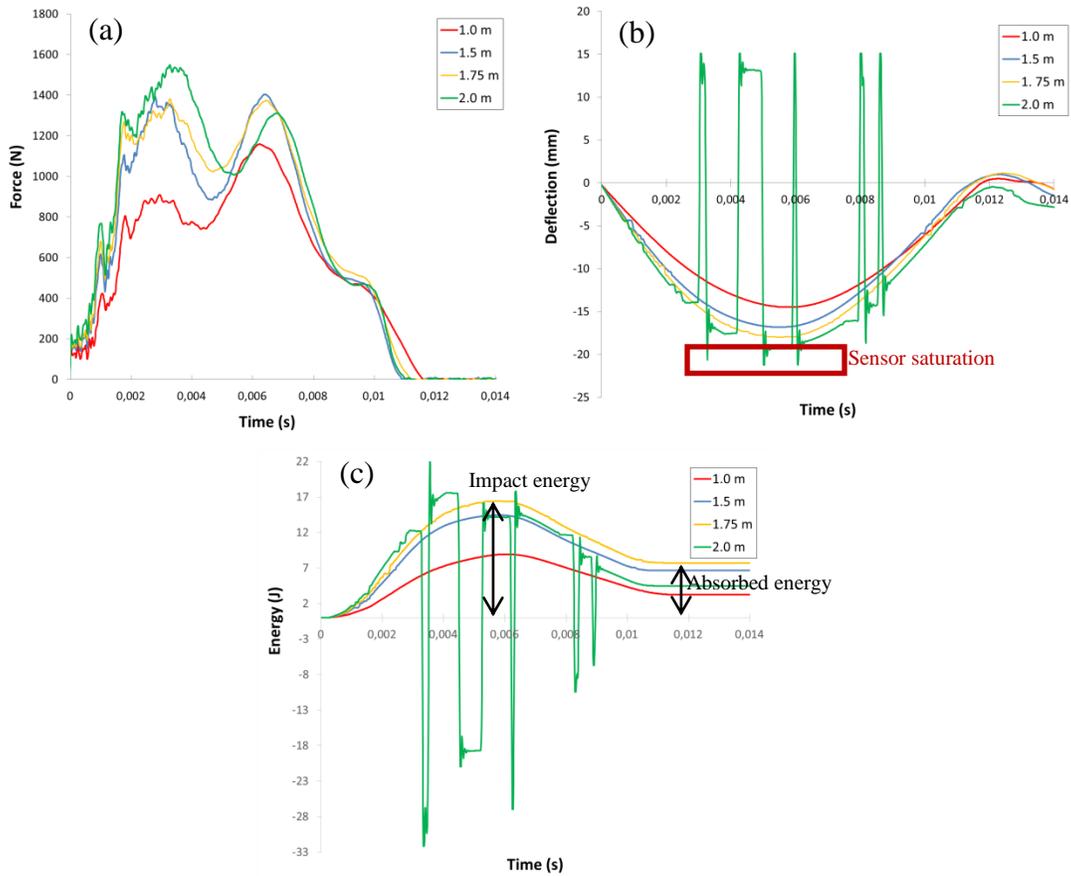
Figure 25 : (a) Courbes force/temps, (b) courbes déplacement/temps et (c) courbes énergie/temps pour les quatre énergies de poids tombant considérées. Le capteur de déplacement sature pour une hauteur de chute de 2.00 M

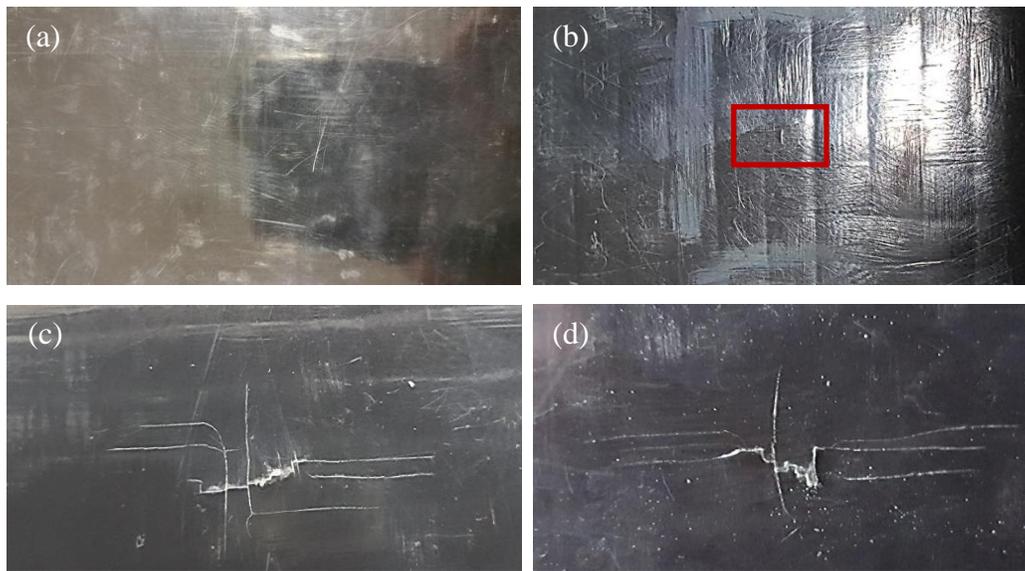
Figure 26 : Faces non-impactée des plaques pour des énergies d'impact de (a) 10 J, (b) 15 J, (c) 17.5 J, et (d) 20 J.

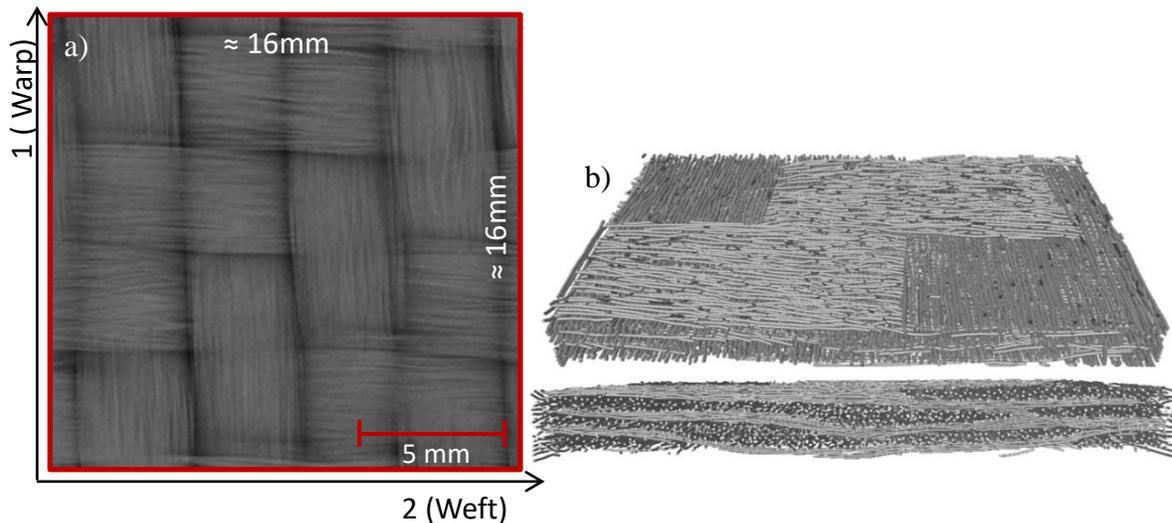
Figure 46 : (a) RVE of the material and (b) 3D representation of the 2/2 twill weave fabric of the Vizilon™ SB63G1-T1.5-S3 obtained by X-ray tomography

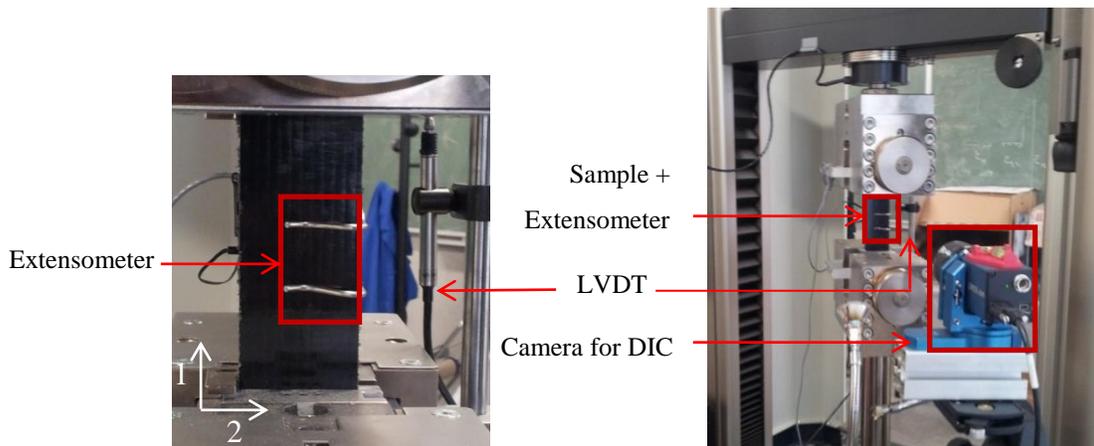
Figure 49 : Experimental set-up of the tensile test with all the displacement measurement sensors

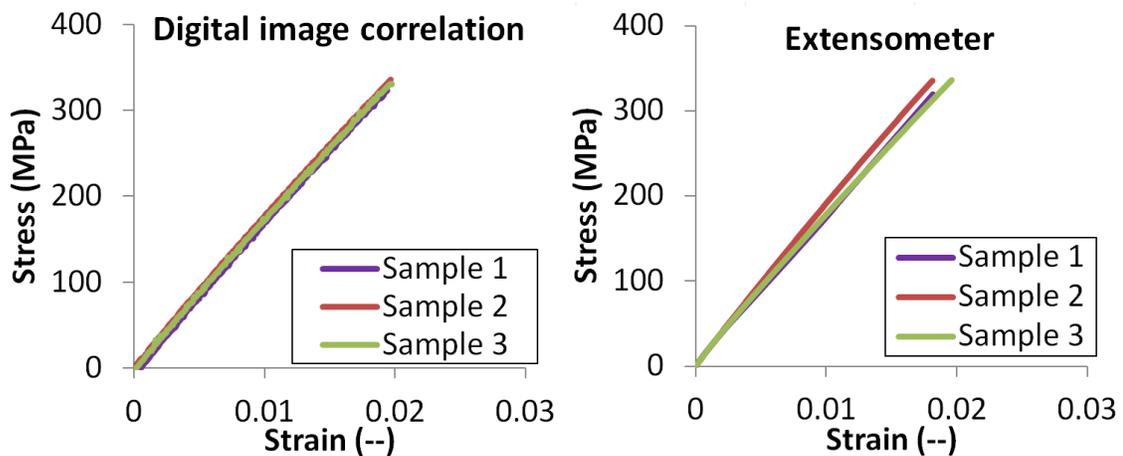
Figure 52 : Stress/Strain curve obtained with DIC (Left) and Extensometer (Right) for the three tested samples oriented at 0° from fiber's axis

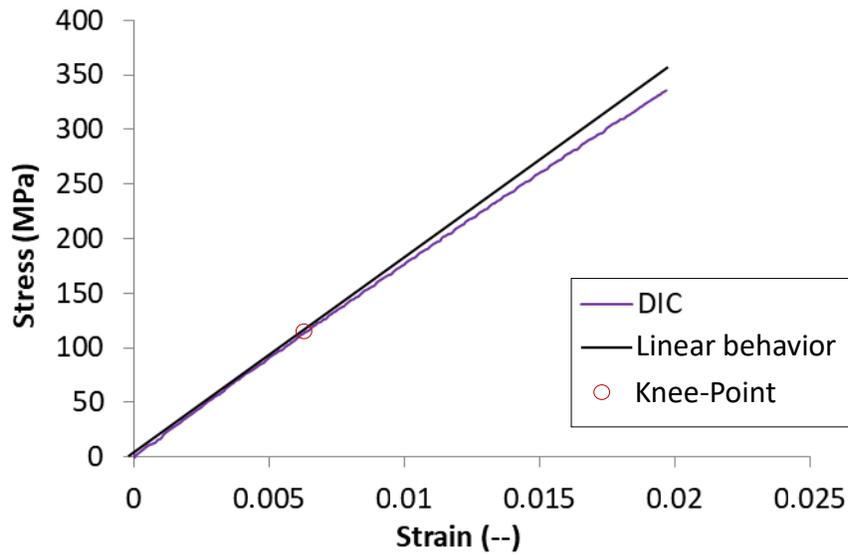
Figure 53 : Nonlinearity point on the stress-strain curve from DIC acquisitions

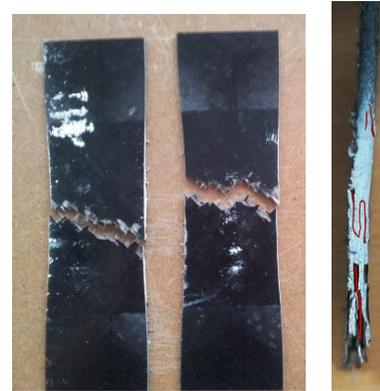
Figure 55 : 45° oriented sample

When the failure area visible in Figure 55 is observed, it can be noted that the crack is running at 45° of the loading direction, which is induced by the fabric orientation. The main crack is propagating in stairs shape; lots of delamination can be observed on the side of the sample relatively close to the failure zone.

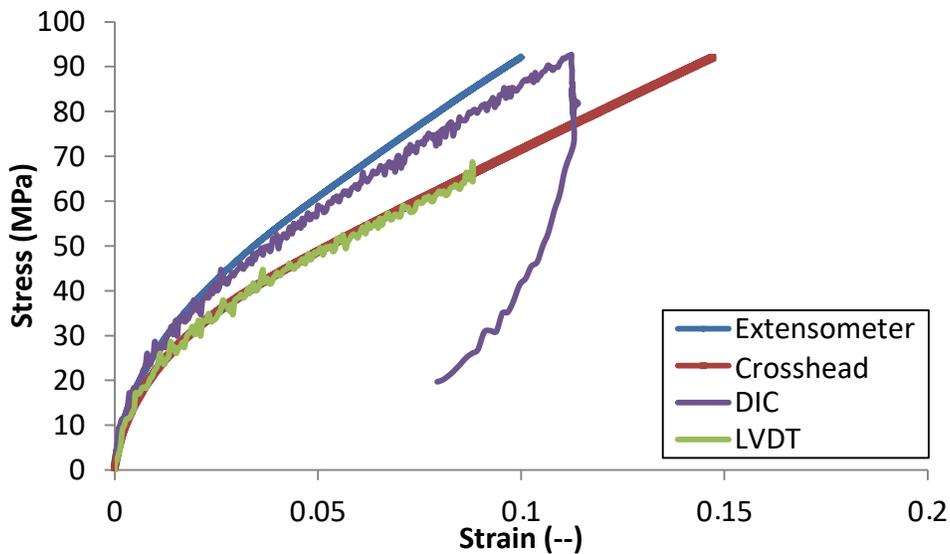
Figure 56 : Stress/Strain curves for the 45° orientation for the entire displacement sensor considered (Here the sample was not solicited until

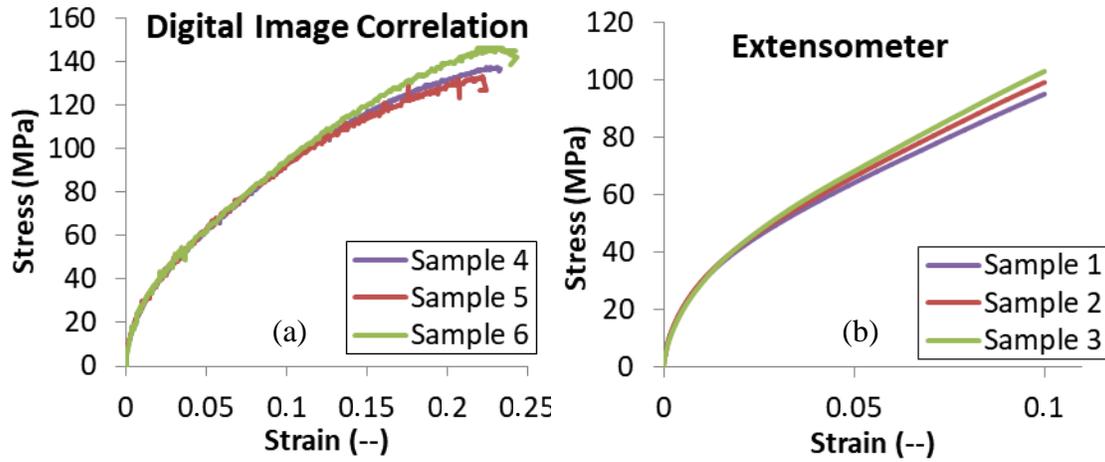
Figure 57 : Stress/Strain curve obtained with DIC (a) and Extensometer (b) for the three tested samples oriented at 45° from fiber's axis

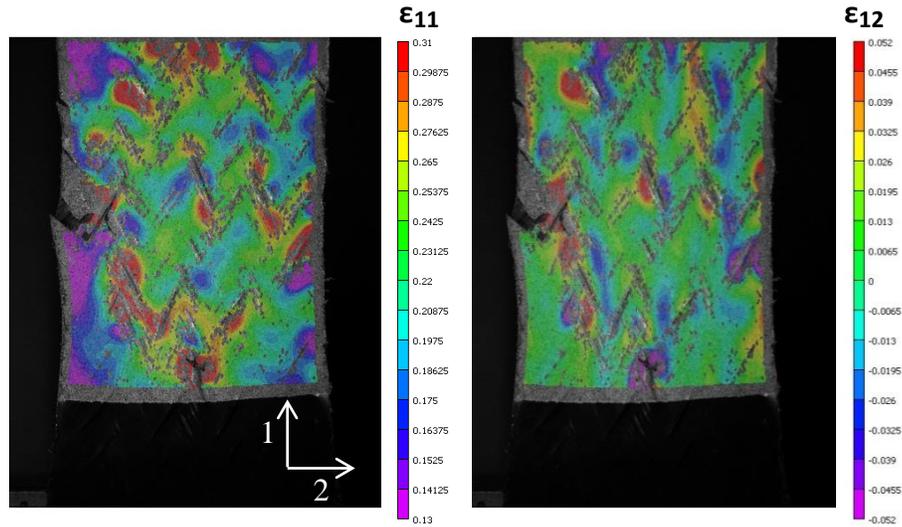
Figure 60 : ϵ_{11} (Left) and ϵ_{12} (Right) strain field for the 45° configuration during a tensile test

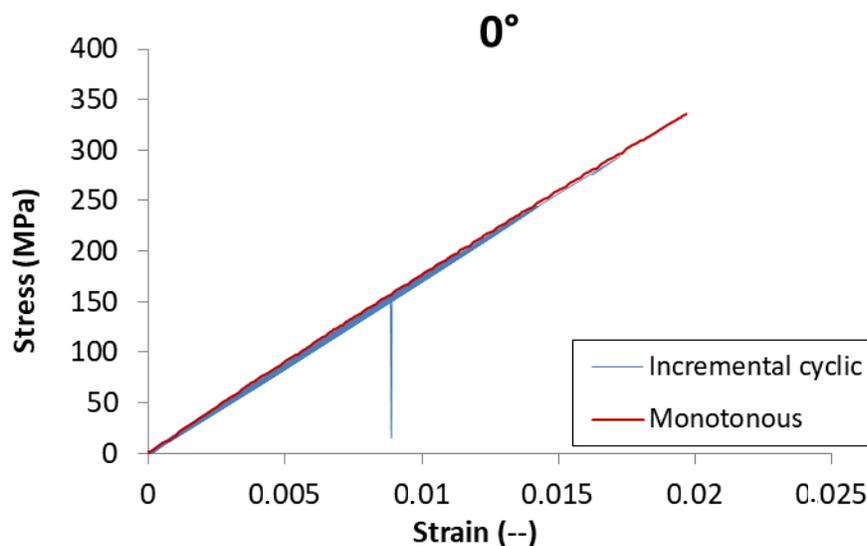
Figure 62 : Monotonic tensile test and incremental (20 MPa) cyclic test for the 0° configuration

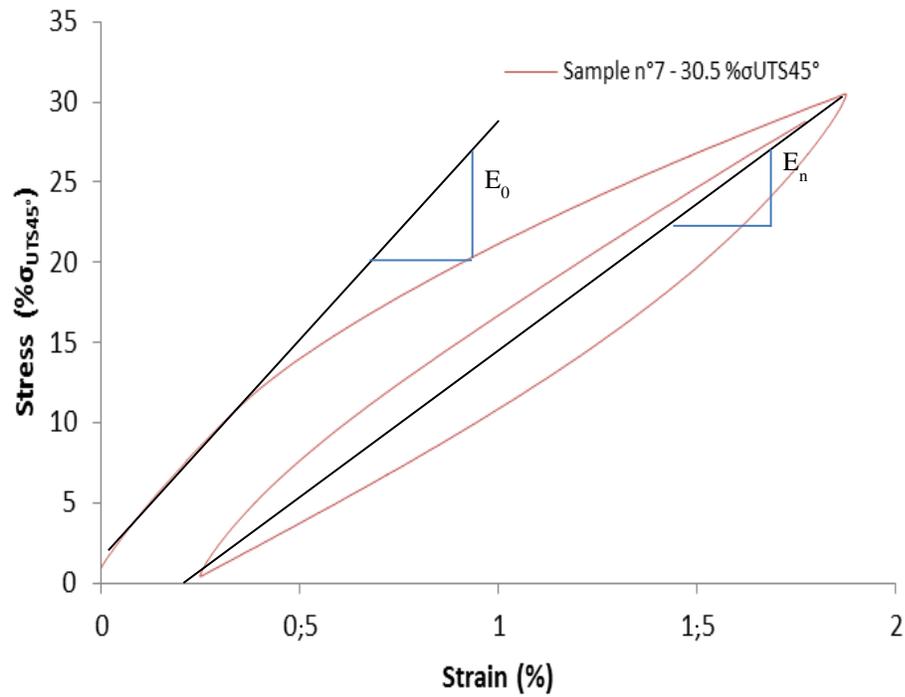
Figure 64 : Measurement of the E_0 and E_n moduli on a loading unloading curve

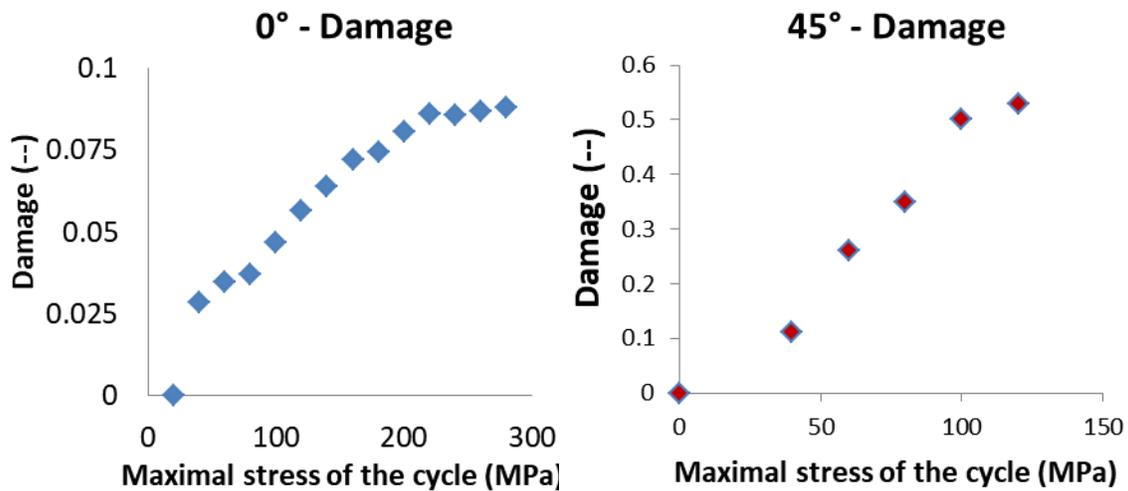
Figure 65 : Evolution of damage function of the maximal stress of the cycle for a 0° (Left) and 45° (Right) oriented sample

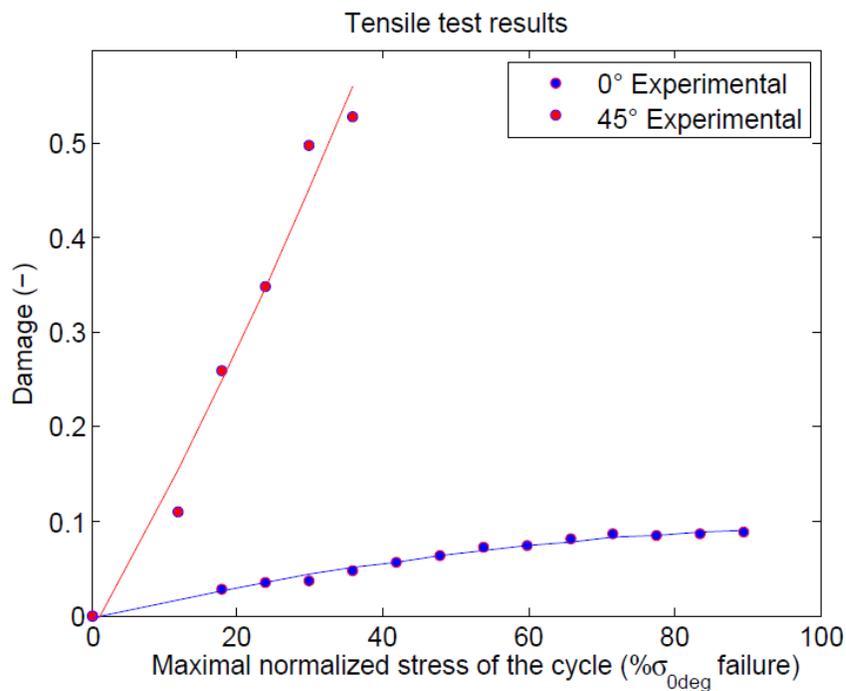
Figure 66 : Comparison of the Young modulus reduction during incremental cyclic test for 0° and 45° oriented samples

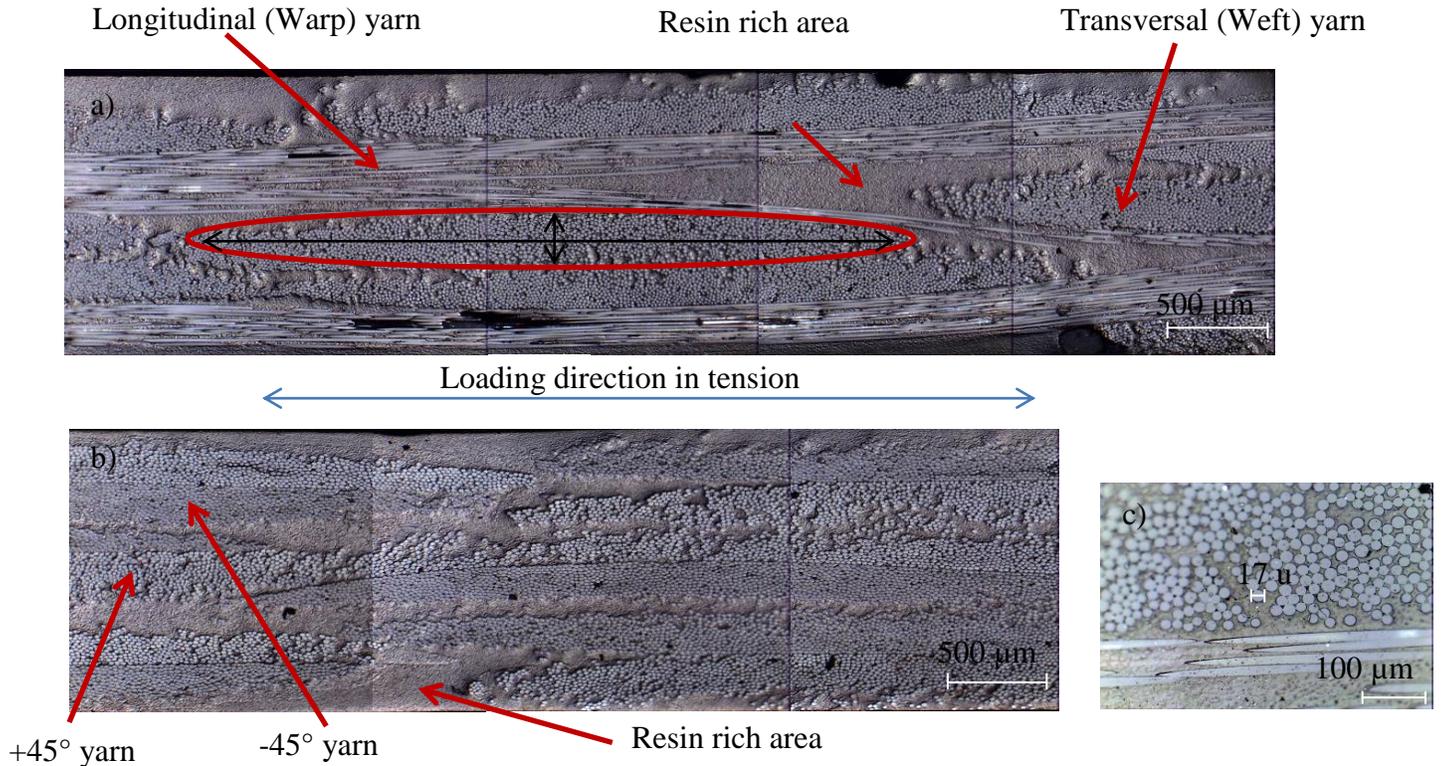
Figure 67: Microstructure observation via optical microscope of the polyamide 66/6 reinforced with woven glass fibers. (a) and (b) depict respectively 0° and 45° configurations. (c) is a magnification on a sample in the 0° configuration

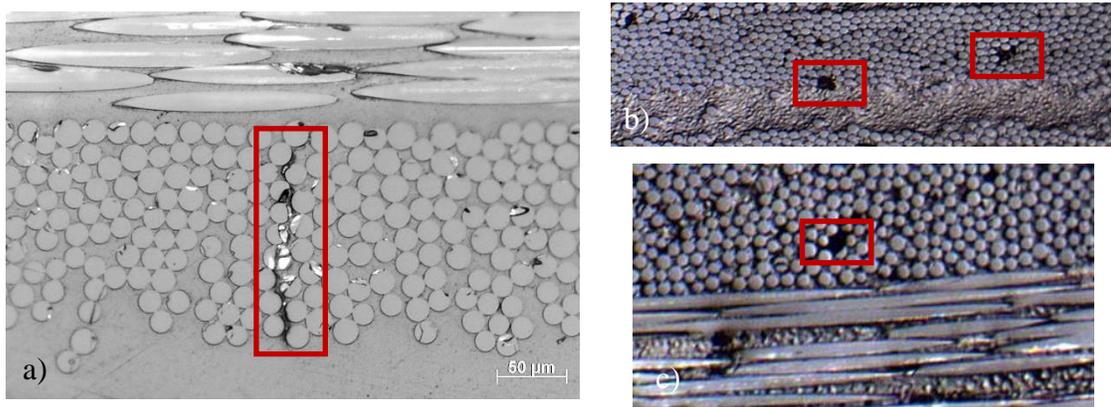
Figure 68 : a) Crack visible in transversal yarns, b) Micro porosities in the 45° configurations c) Micro porosities in the 0° configurations.

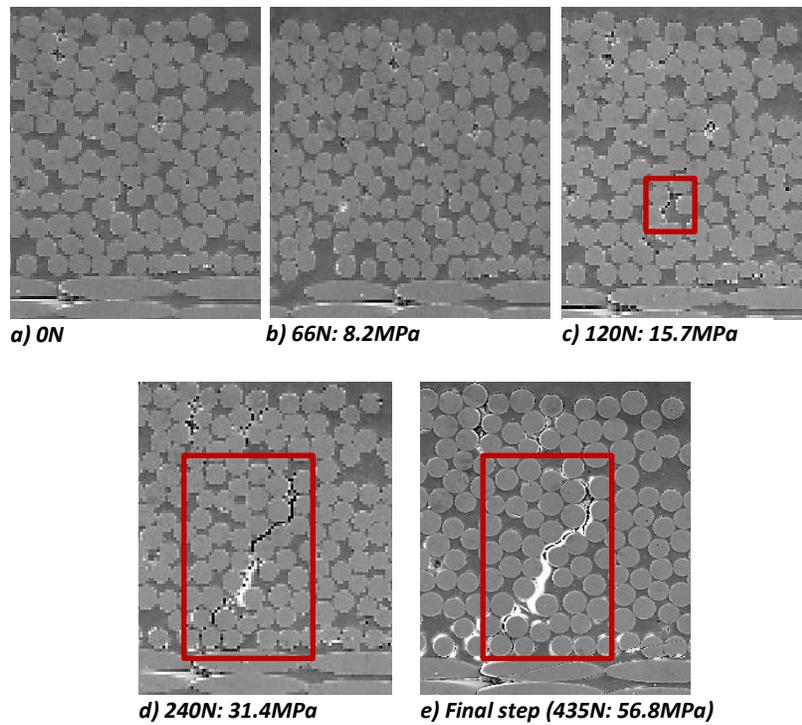
Figure 69 : Transversal yarns during SEM in-situ tensile test for different applied force

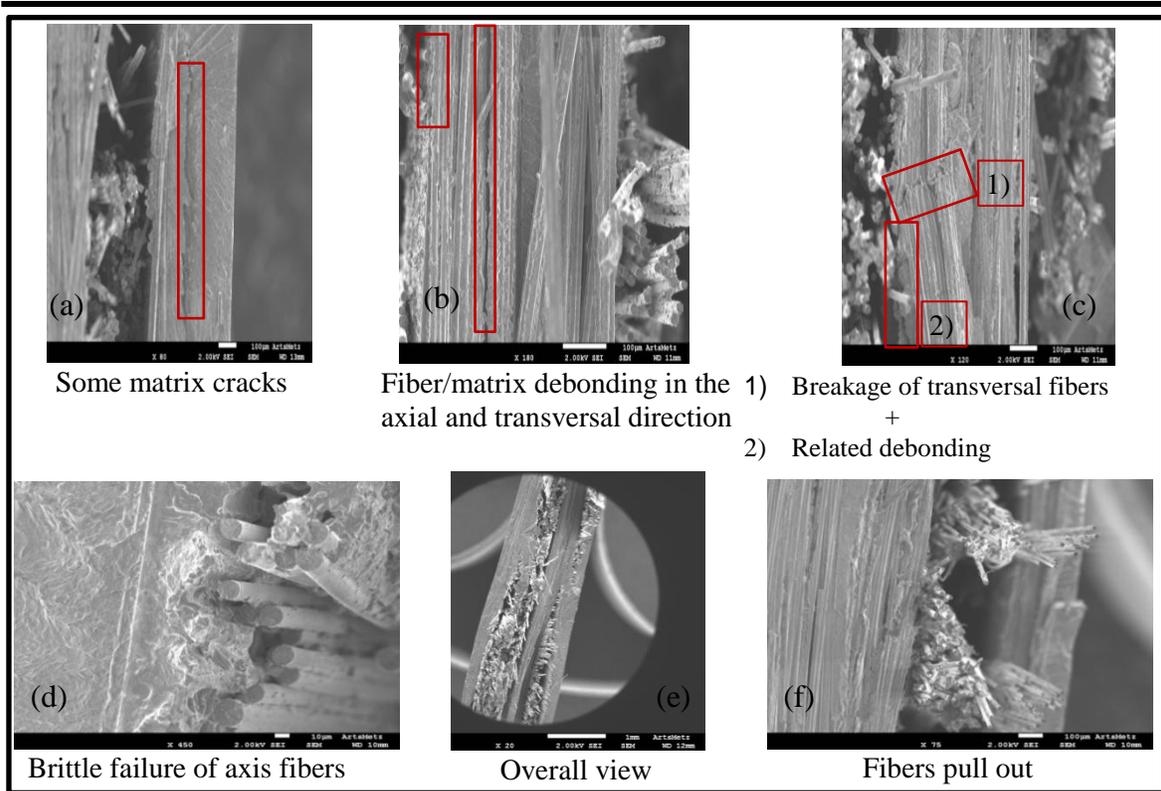
Figure 71 : Rupture mechanisms observed for samples oriented along the fiber axis

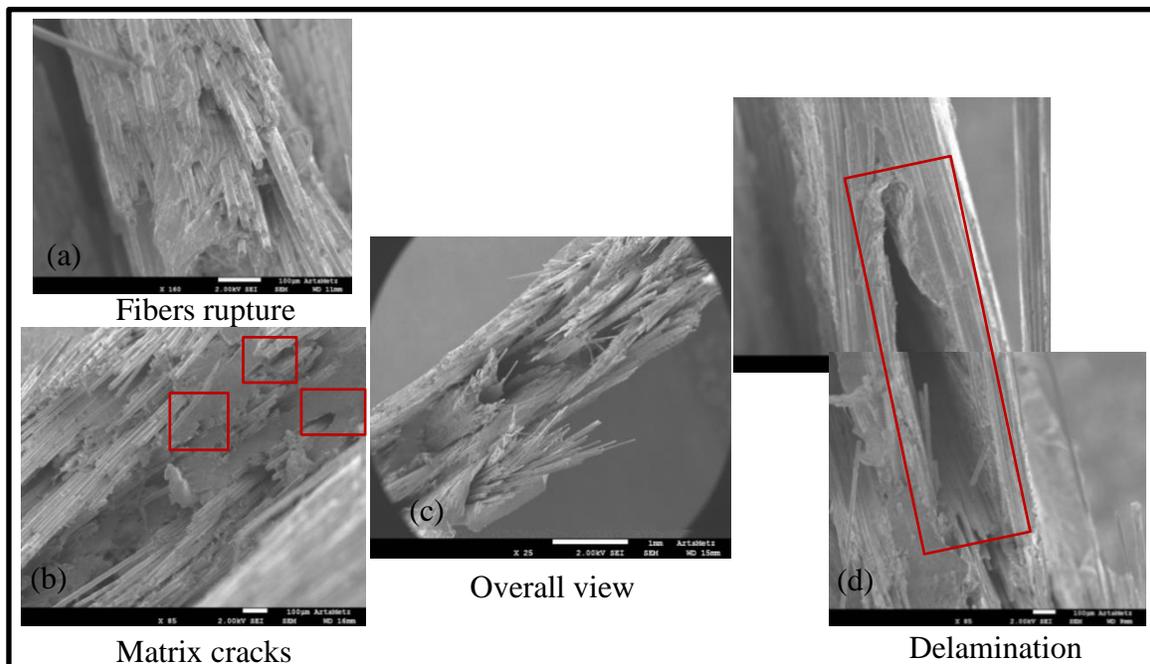
Figure 72 : Rupture mechanisms observed for samples oriented at 45° from fiber axis

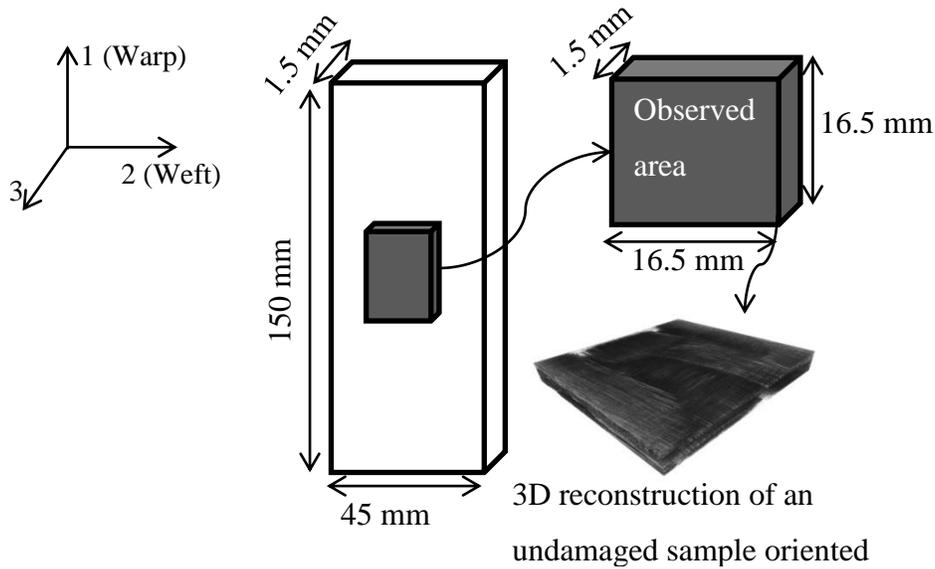
Figure 75 : Schematic representation of the observed area on a polyamide 6,6 /Woven glass fiber samples and the associated 3D reconstruction

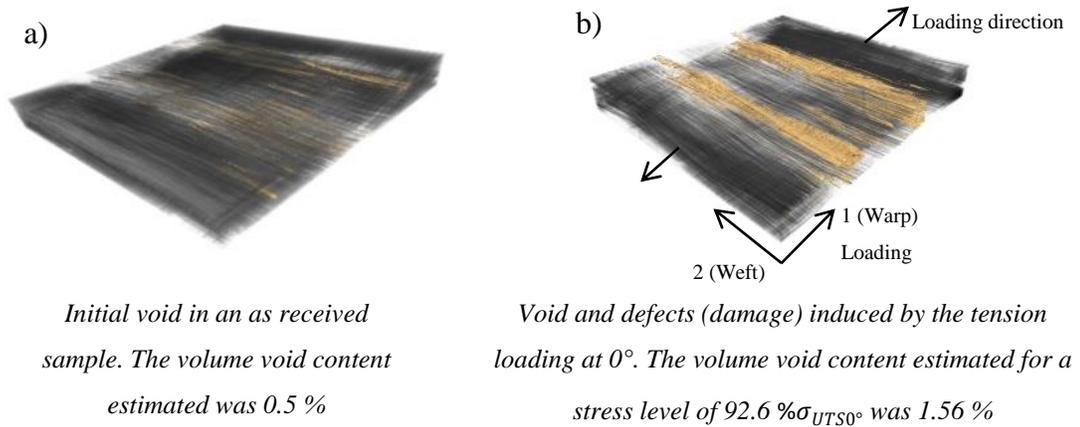
Figure 80 : mCT-3D reconstructions of composite samples in the 0° configuration respectively (a) before and (b) after tensile loading at a stress level of 92.6 % σ_{UTS0°

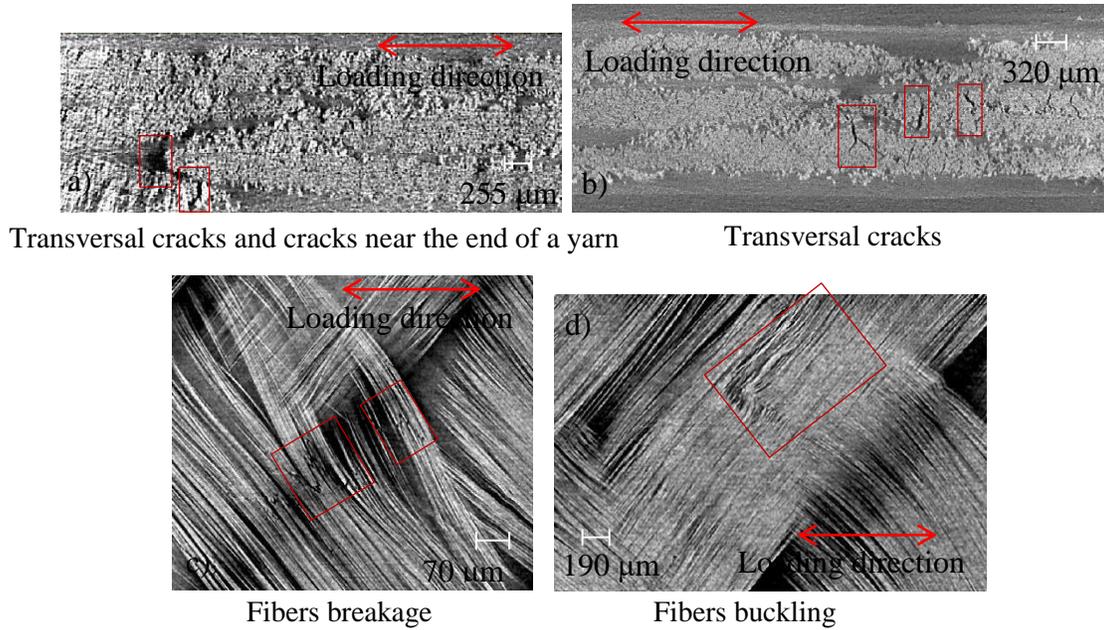
Figure 82 : Damage mechanisms observed in woven composite sample loaded in tension at 45° from the warps axis.

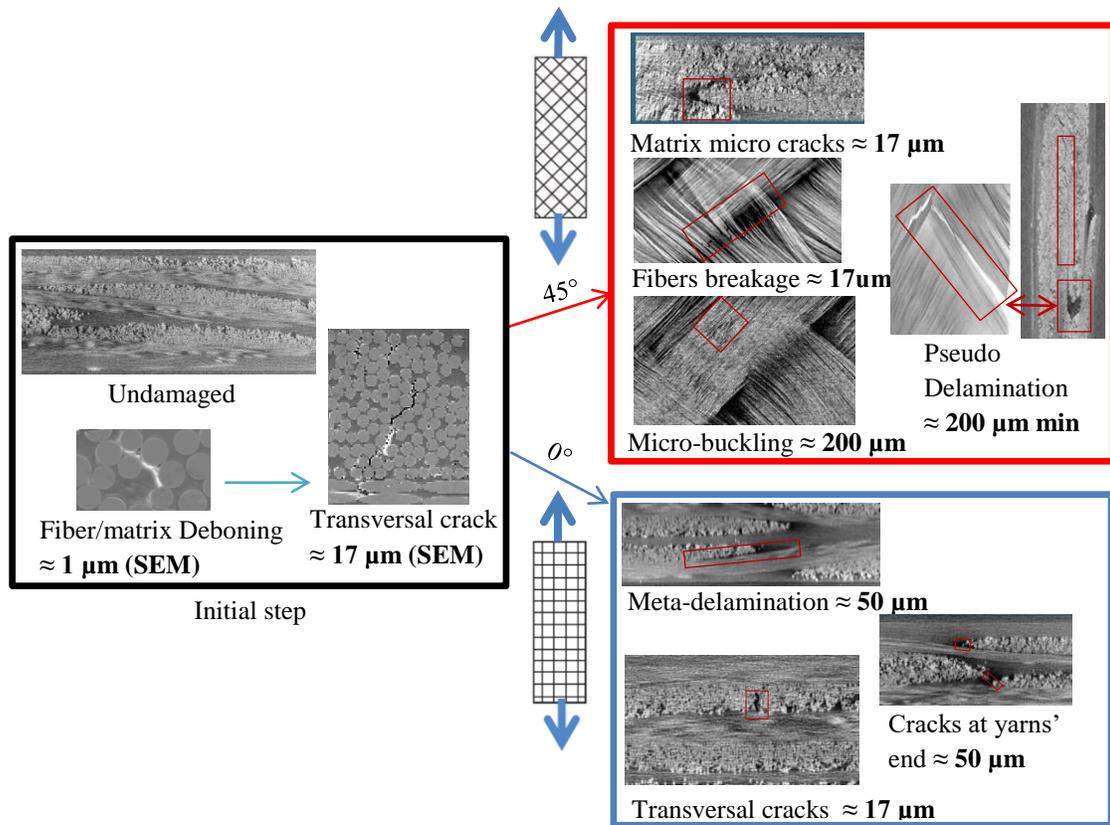
Figure 85 : Summary of the damage mechanisms and their associated typical scale for both 0° and 45° oriented samples.

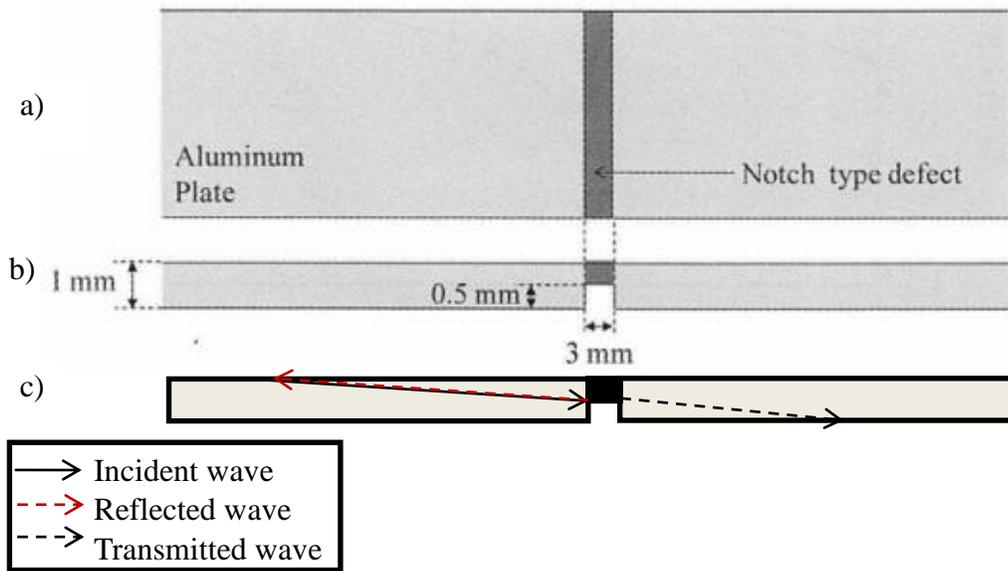
Figure 103 : Schematic representation of the considered aluminum sample with a notch type defect. a) Top observation, b) Side observation, c) Side observation + ultrasonic wave's propagation through the sample (Based on [77])

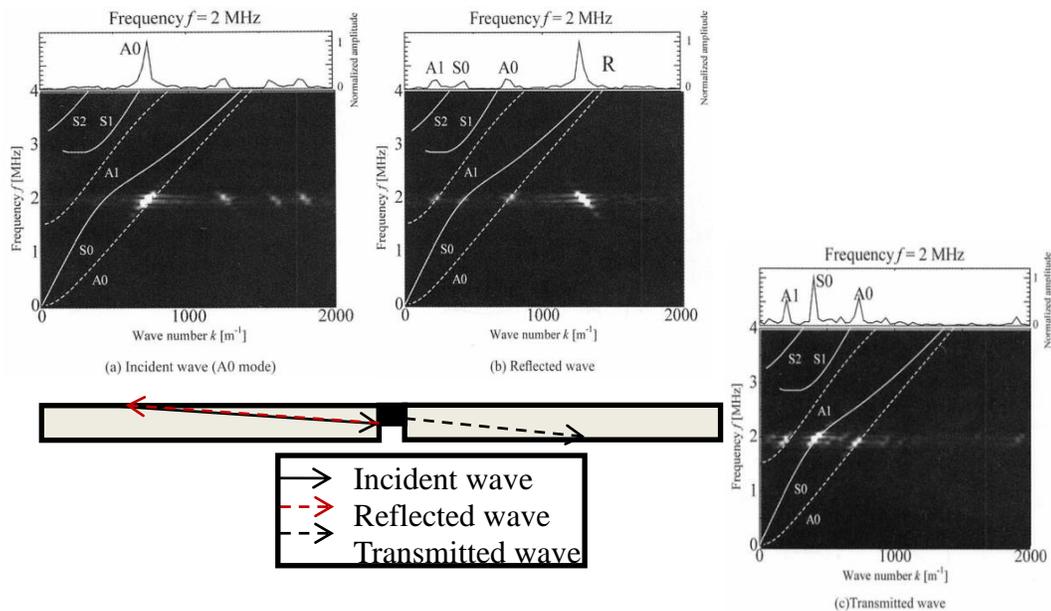
Figure 104 : Side observation of the sample + ultrasonic wave's propagation through the sample. 2D Fourier transform results for the incident, reflected and transmitted wave with the theoretical dispersion curves. (Based on [77])

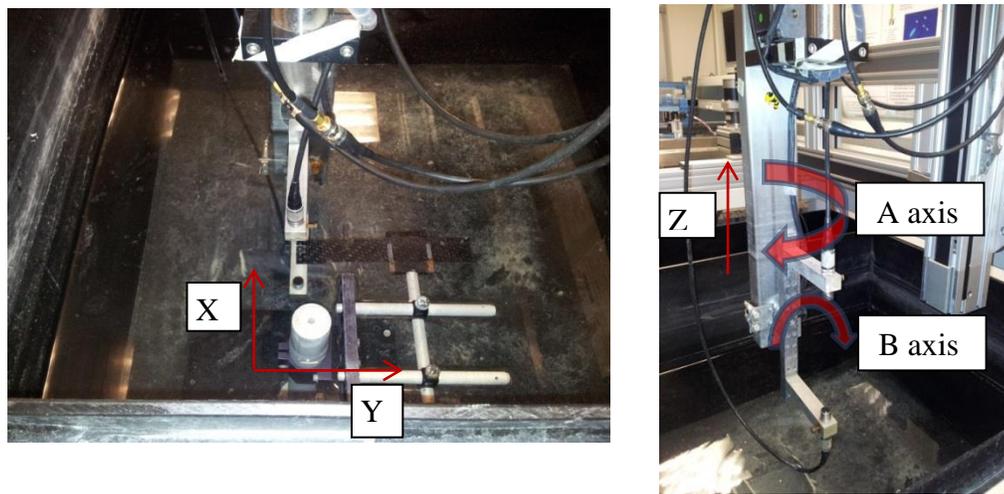
Figure 113 : LUNE lab's 5 axis ultrasonic robot from Inspection Technology

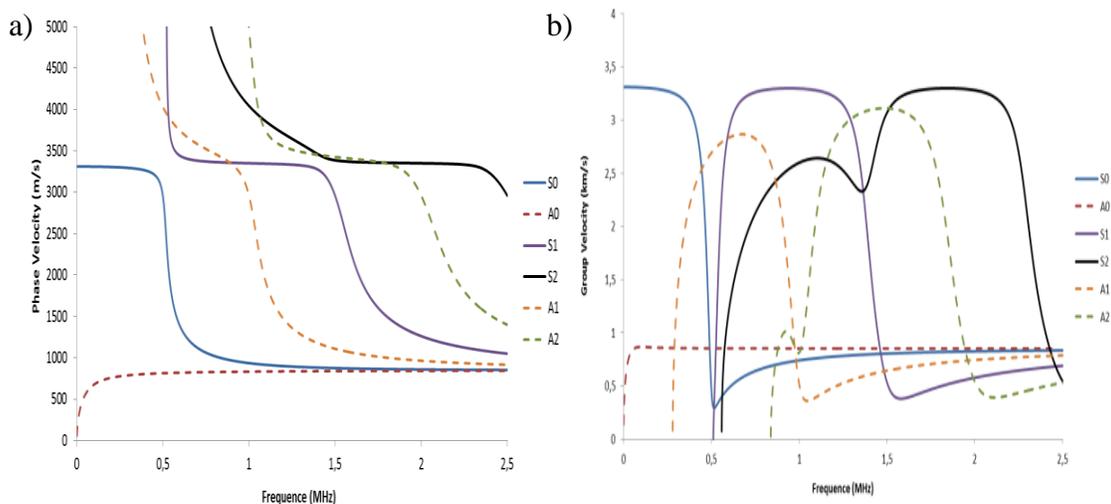
Figure 122 : Dispersion curves computed with the *Disperse software* for guided wave propagation in a 1.53mm thick studied composite along the fibers direction.

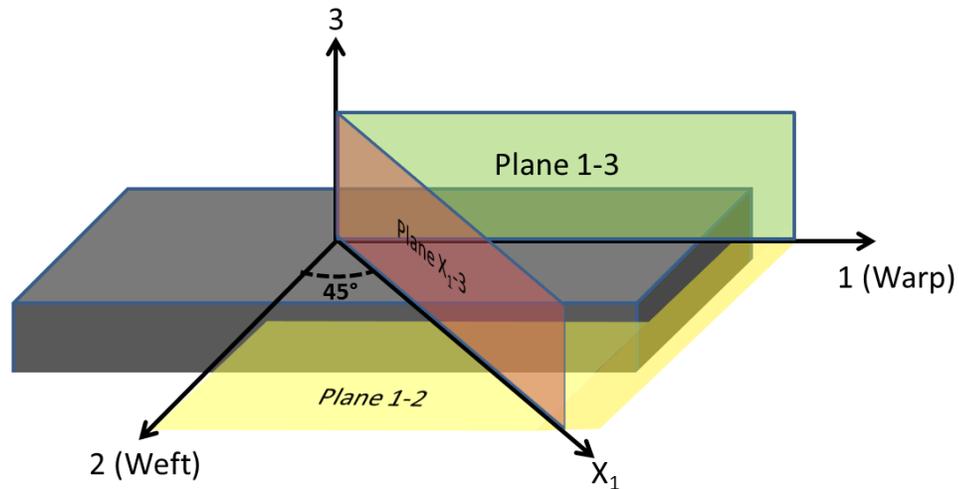
Figure 128 : Schematic representation of the different propagation planes of ultrasonic waves. For samples in the 0° configurations, the planes 1-3 and 1-2 were used. For the samples in the 45° configuration, the plane X_1 -3 and 1-2 were used.

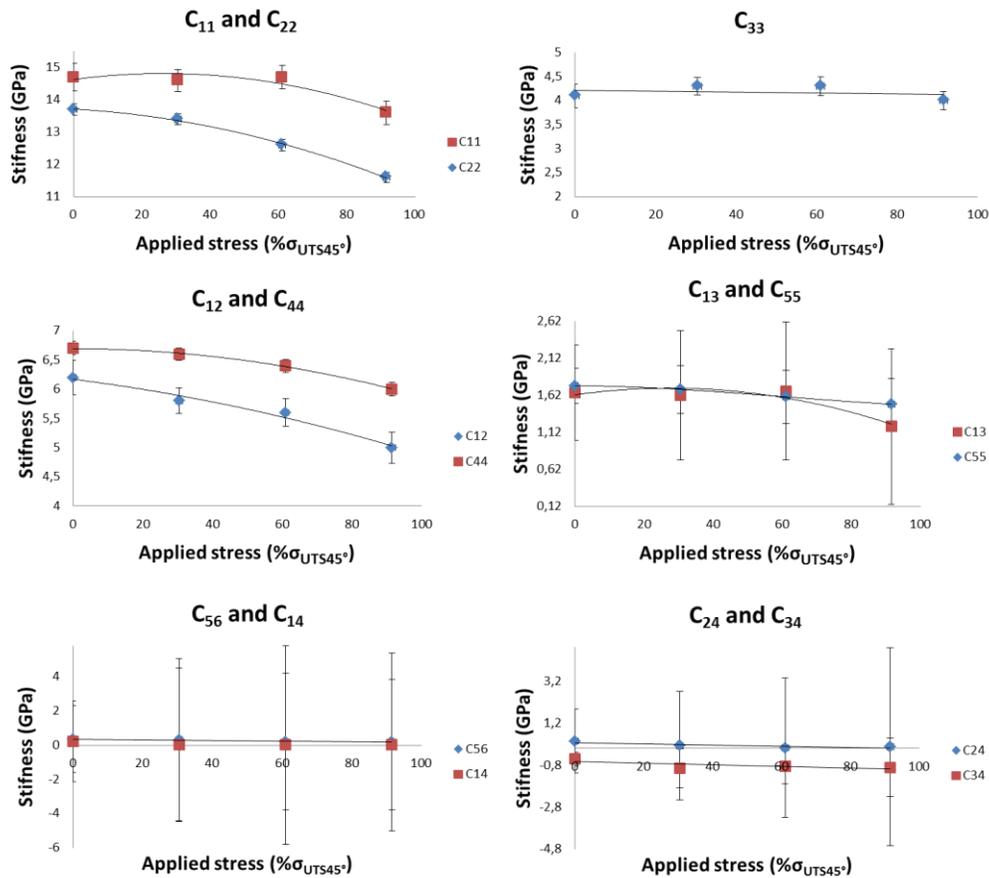
Figure 130 : Evolution of eleven of the rigidity constants with the increase of the loading for different 45° oriented sample with a third order interpolation
