Détection de l'endommagement dans un composite tissé PA66,6/Fibres de verre à l'aide de techniques ultrasonores en vue d'une prédiction de la durabilité de pièces automobiles

T H È S E

Pascal POMAREDE

Damage detection in PA 66/6|Glass woven fabric composite material using ultrasonic techniques towards durability prediction of automotive parts

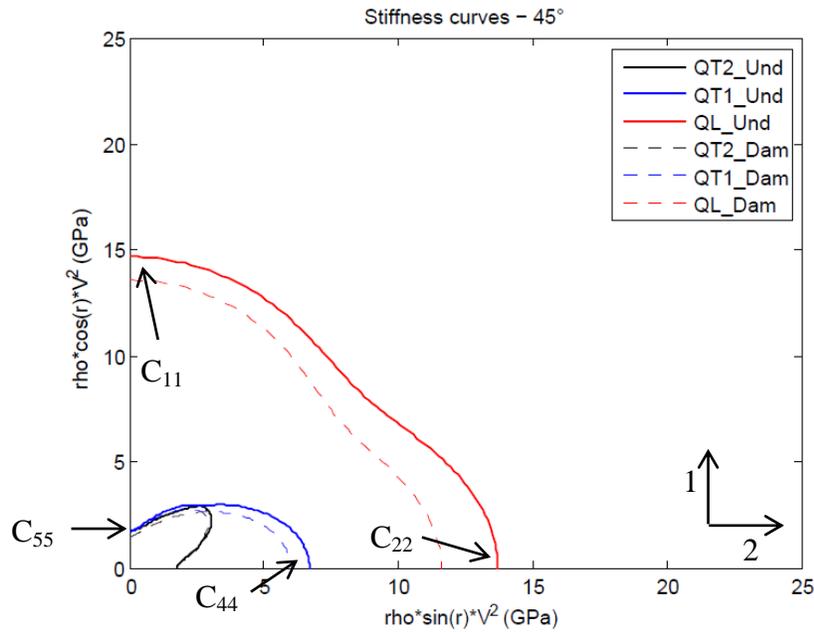
Figure 131 : Stiffness curves for two samples oriented at 45° from the fiber's axis. An undamaged sample and a sample loaded in tension at 120MPa

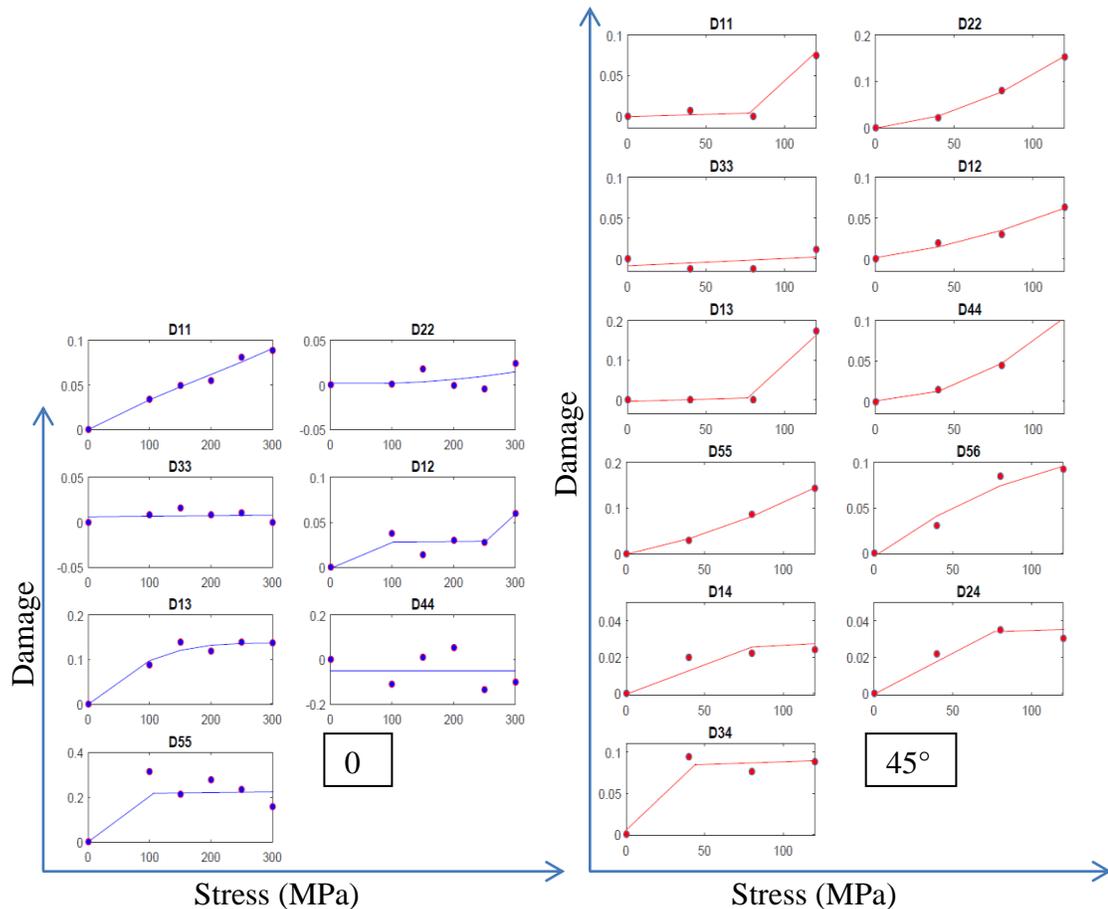
Figure 132 : Damage evolution with stress level of samples oriented at 0° and 45° obtained via ultrasonic measurements

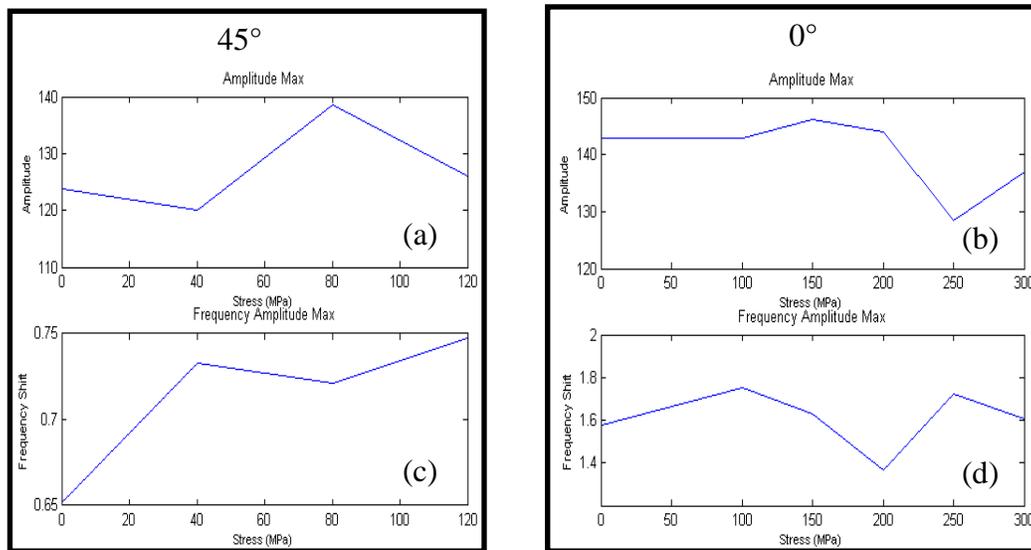
Figure 133 : Evolution of the maximal amplitude for sample in the (a) 0° configuration and (b) 45° configuration. Evolution of the frequency shift for sample in the (c) 0° configuration and (d) 45° configuration.

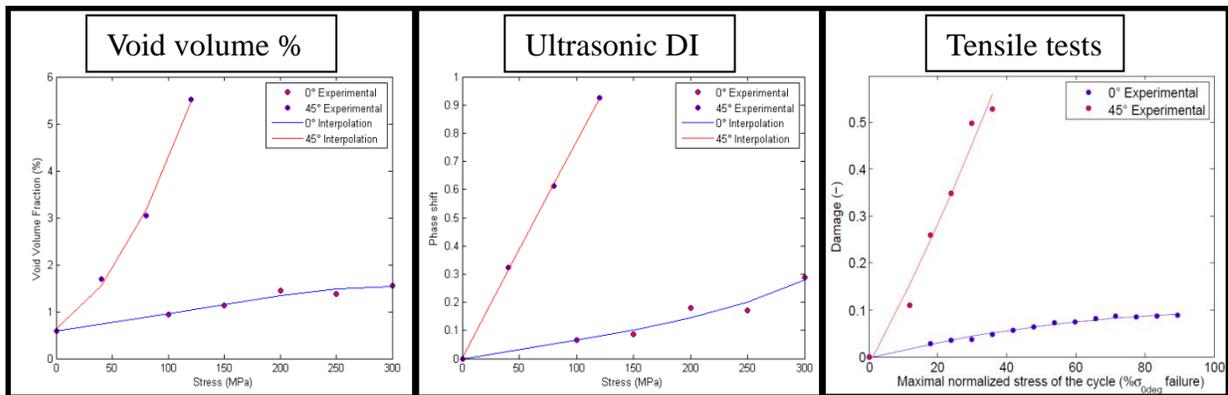
Figure 136 : Evolution of the void volume fraction evolution measured with X-ray tomography; Signal phase shift measured with an ultrasonic method and the elastic modulus loss measured during incremental cycling tensile tests

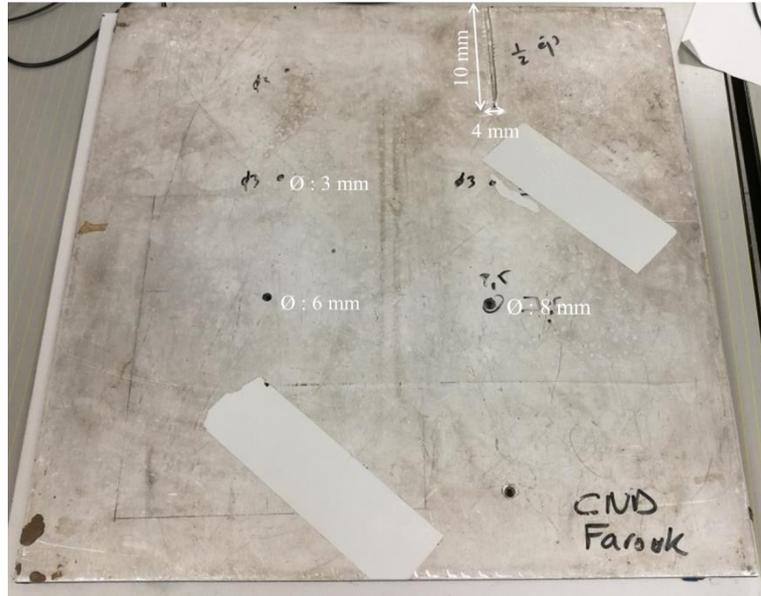
Figure 137 : Investigated aluminum plate. Several defects are appearing in the plate, mostly holes of different diameter. A large notch is also visible

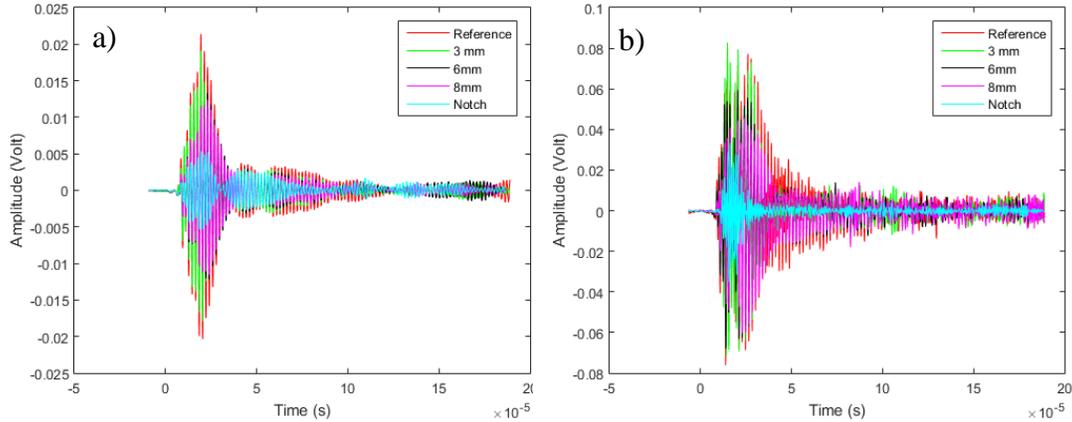
Figure 138 : Transmitted signal for different defects and a reference case when a burst of a) 500KHz and b) 1MHz is emitted

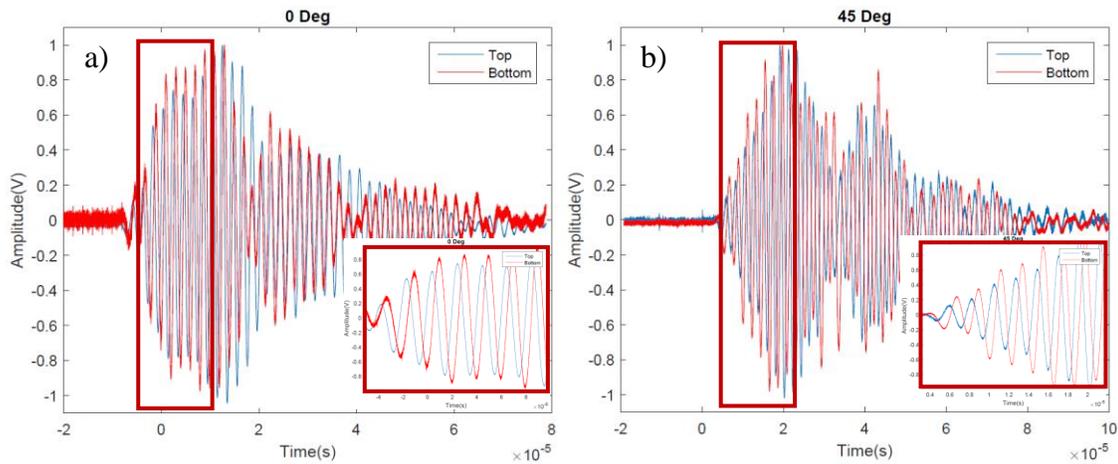
Figure 148 : Typical signals measured on top and bottom surface of sample in the (a) 0° configuration and (b) 45° configuration

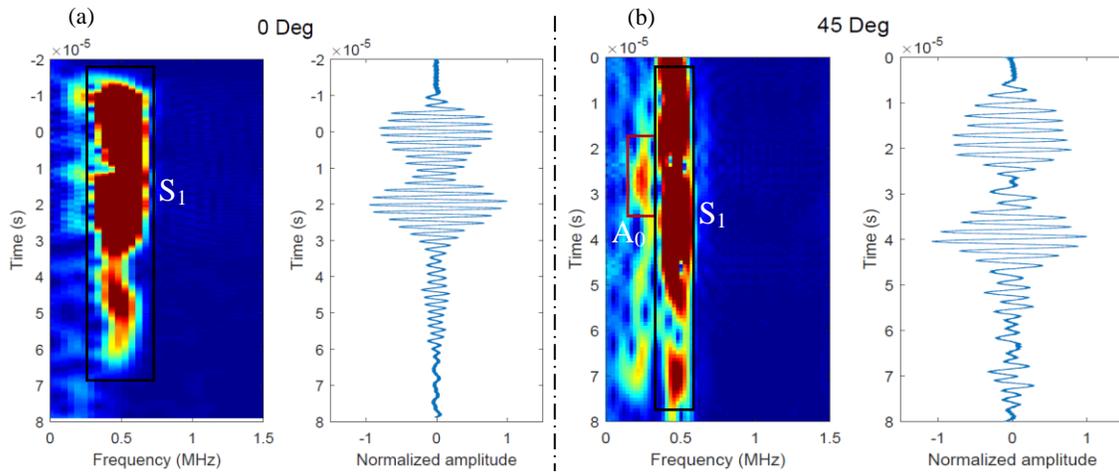
Figure 149 : Spectrogramme d'un signal transmis dans un échantillon dans (a) la configuration 0° et (b) la configuration 45° avec le signal temporel correspondant

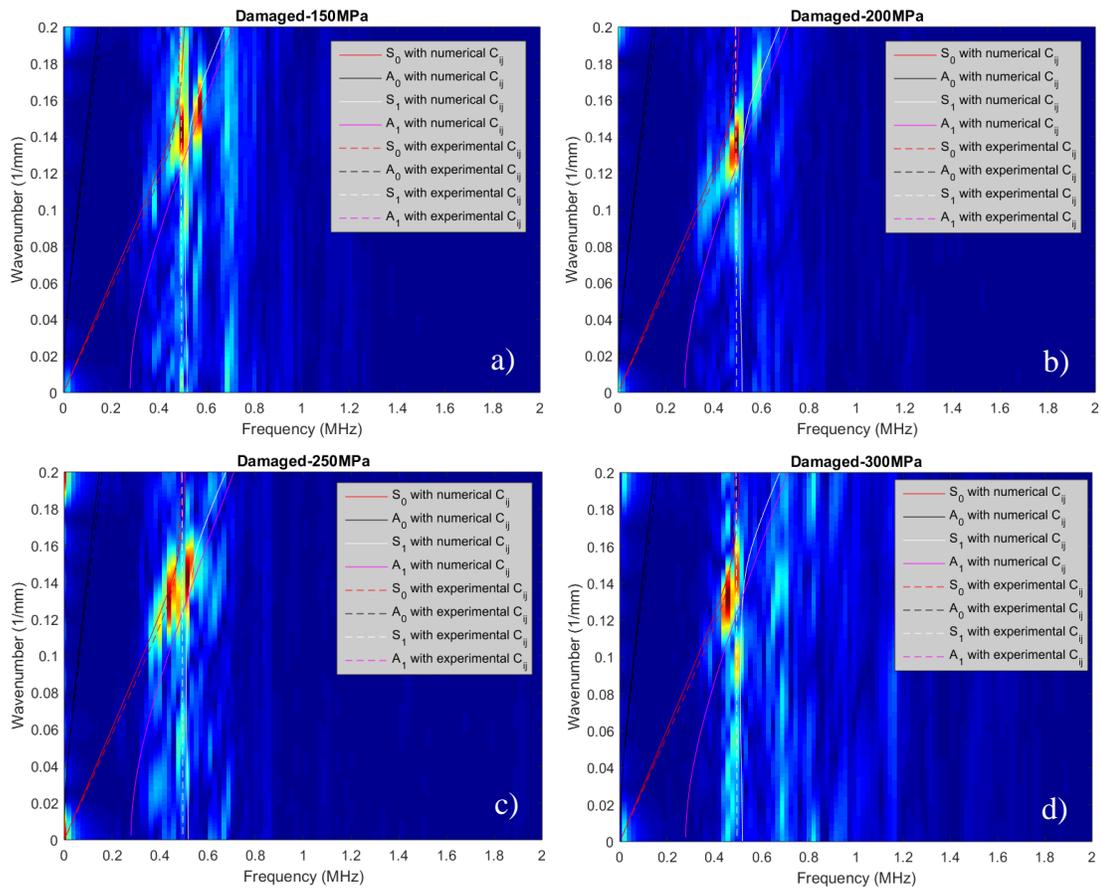
Figure 150 : 2D Fast Fourier Transform for the samples, in the 0° configuration, loaded in tension at a) 150, b) 200, c) 250 and d) 300MPa.

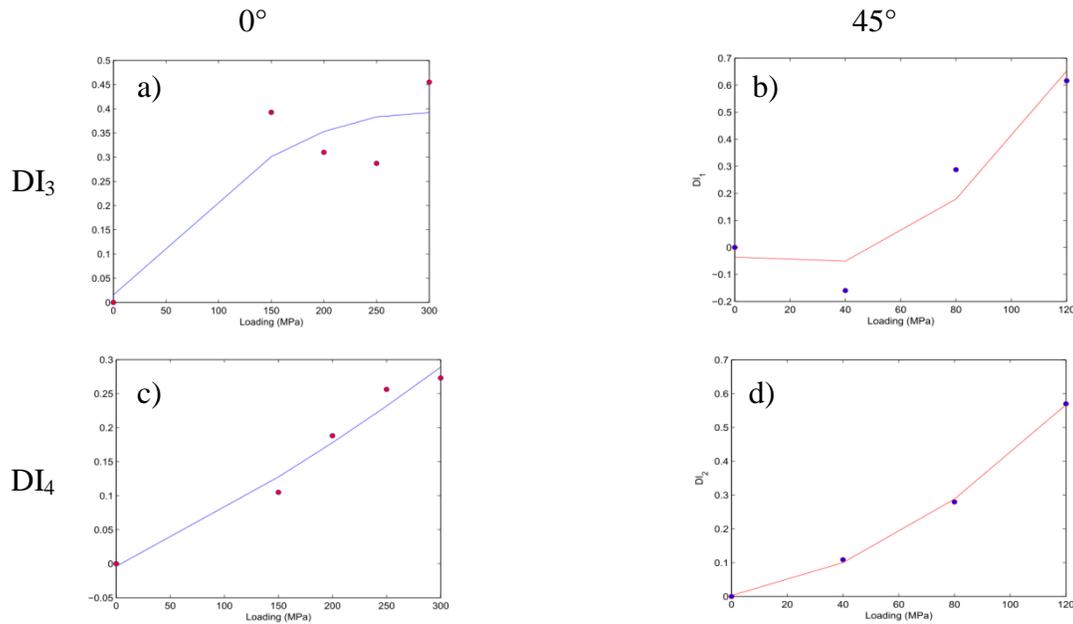
Figure 153 : Evolution the damage indicators DI_3 for the samples oriented at 0° and 45° in respectively a) and b).

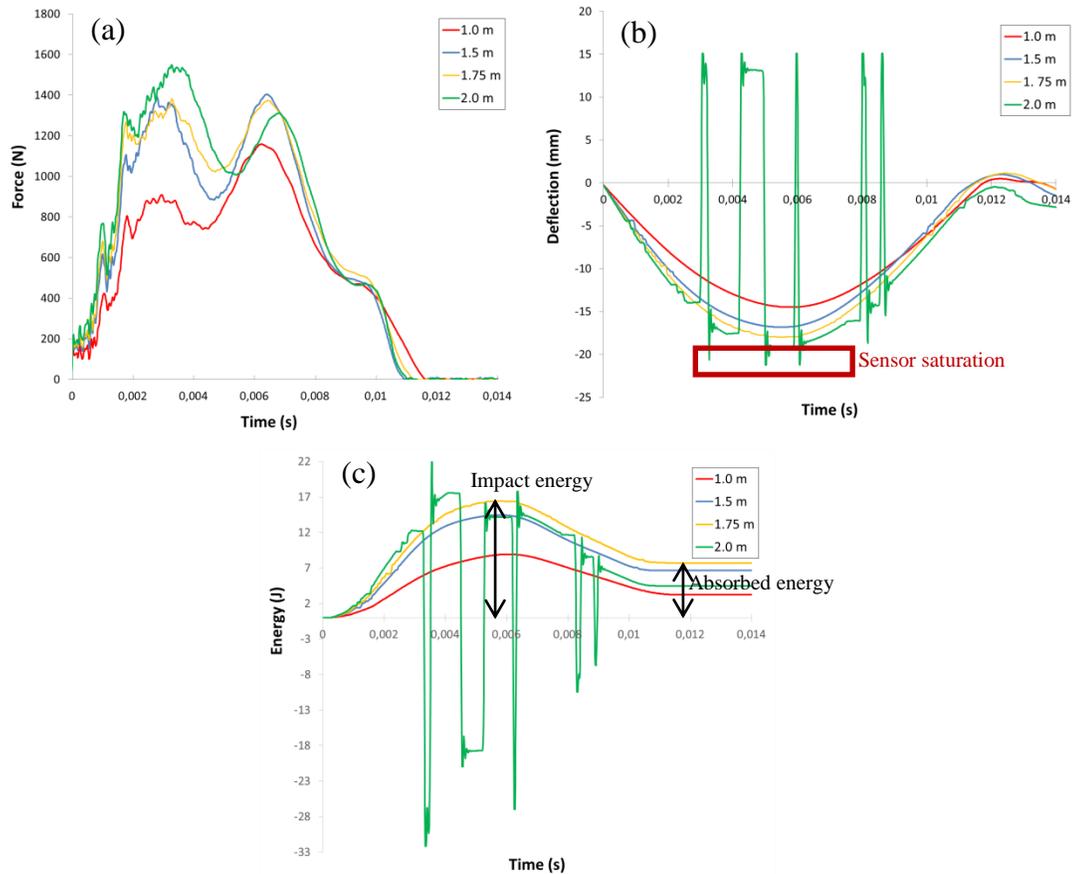
Figure 156 : (a) Force time curves, (b) displacement time curves and (c) Energy time curves for the four considered drop weight energies. The displacement sensor saturates during the 20 J impact test.

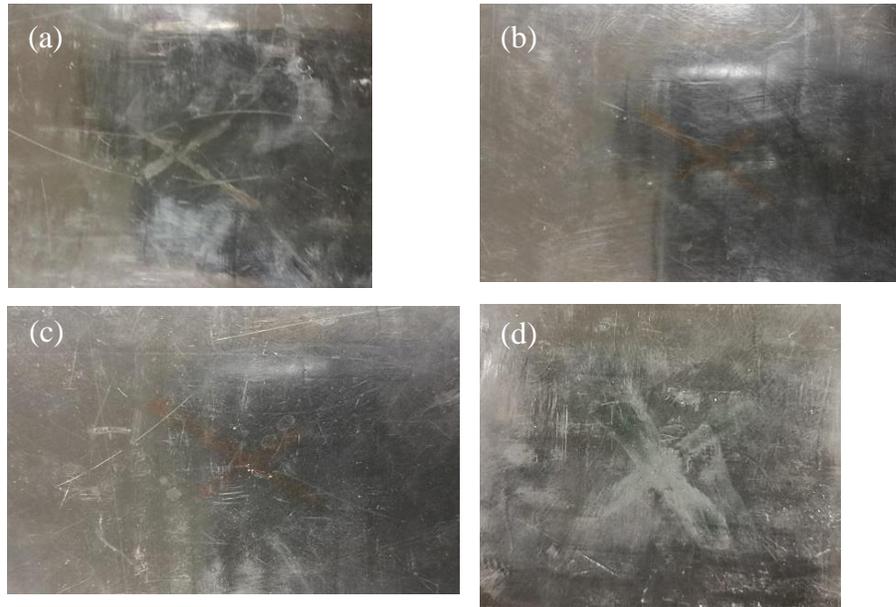
Figure 157 : Visual observation of the plates on the impacted side for an impact energy of (a) 10, (b) 15, (c) 17.5 and (d) 20 J

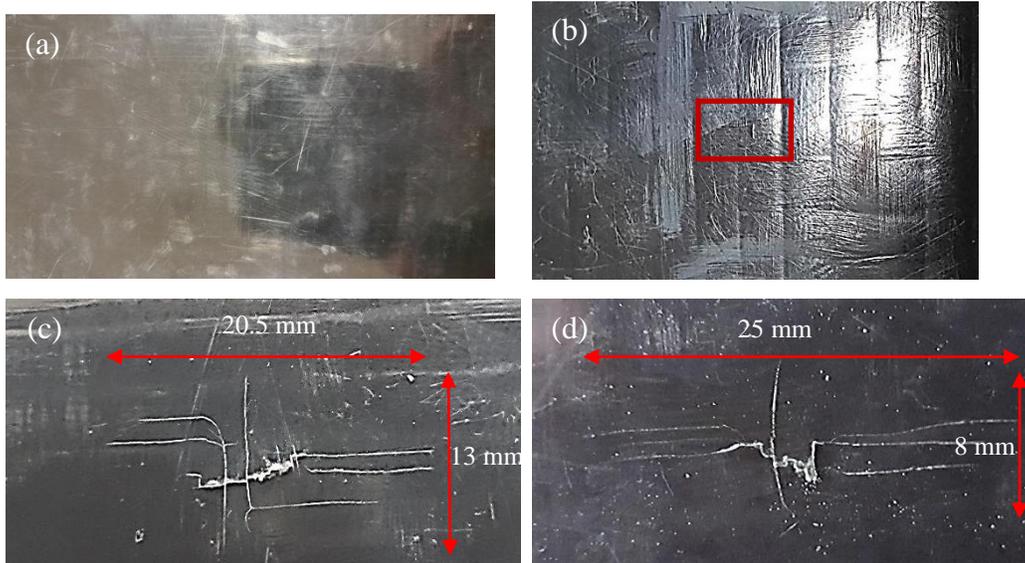
Figure 158 : Visual observation of the damage in the plates on the opposite of the impacted side for an impact of (a) 10, (b) 15, (c) 17.5 and (d) 20 J

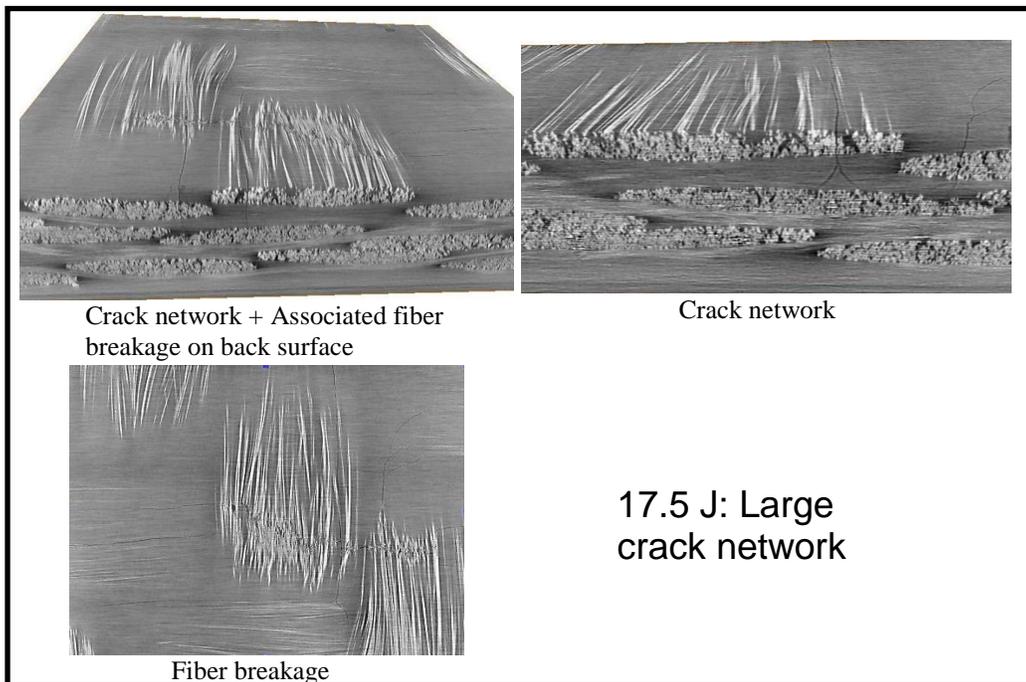
Figure 159 : X-ray tomography observations performed on the impacted at an energy level of 17.5 J

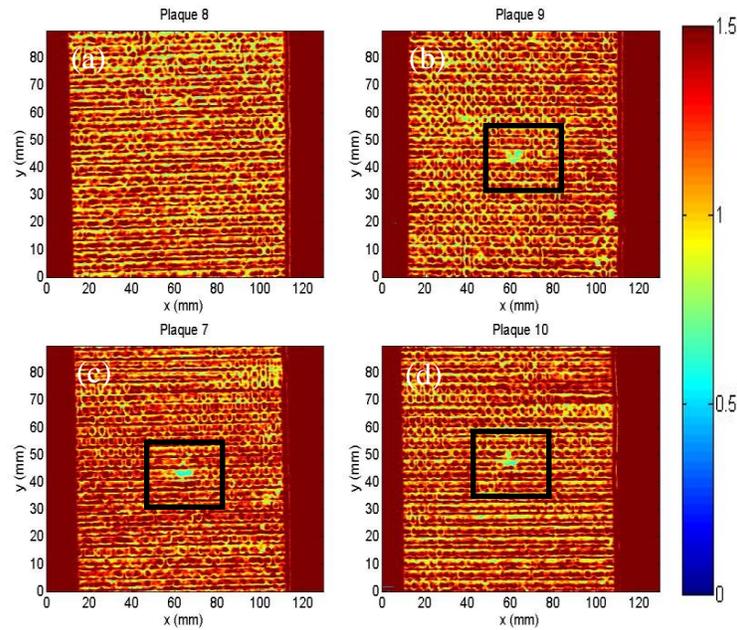
Figure 162 : Ultrasonic C-scan imaging in transmission with 10 MHz transducers for the plates impacted at an energy level of (a) 10, (b) 15, (c) 17.5 and (d) 20 J

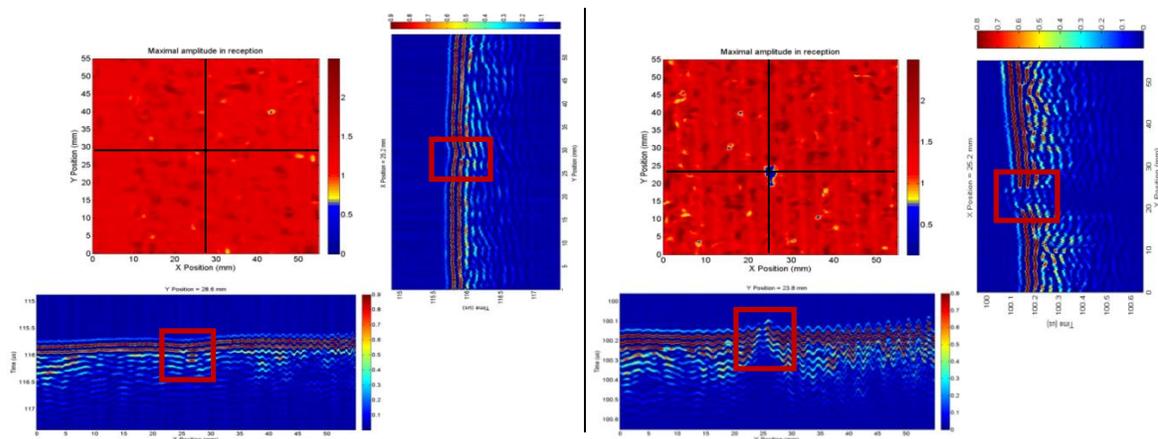
Figure 164 : Ultrasonic imaging in reflection of the plate impacted at 20 J. Impacted side (Left) and the opposite one (Right). B-scan in the X and Y directions for both side.

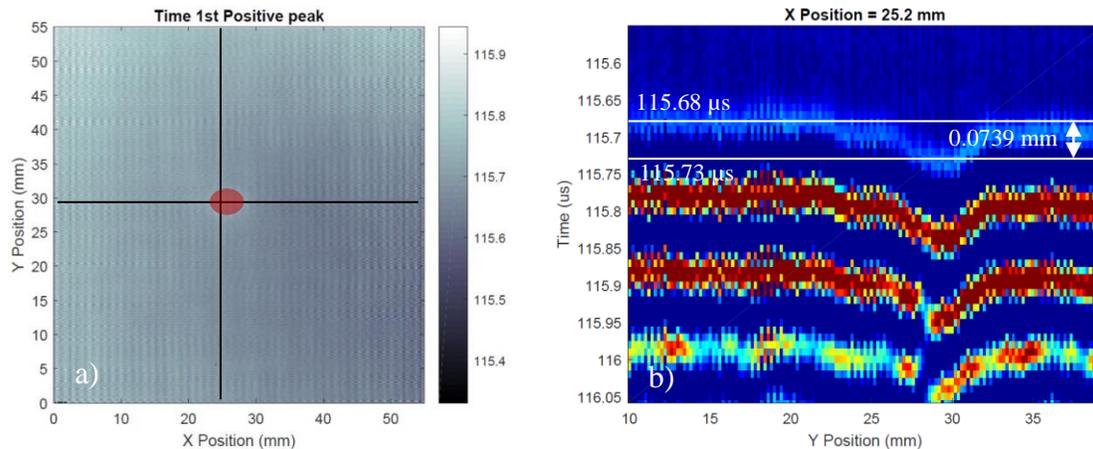
Figure 166 : (a) Times of arrival map for the first peak in the plate impacted at 20 J. The permanent indentation is highlighted in red (b) Zoom in on one of the b-scan from Figure 164.

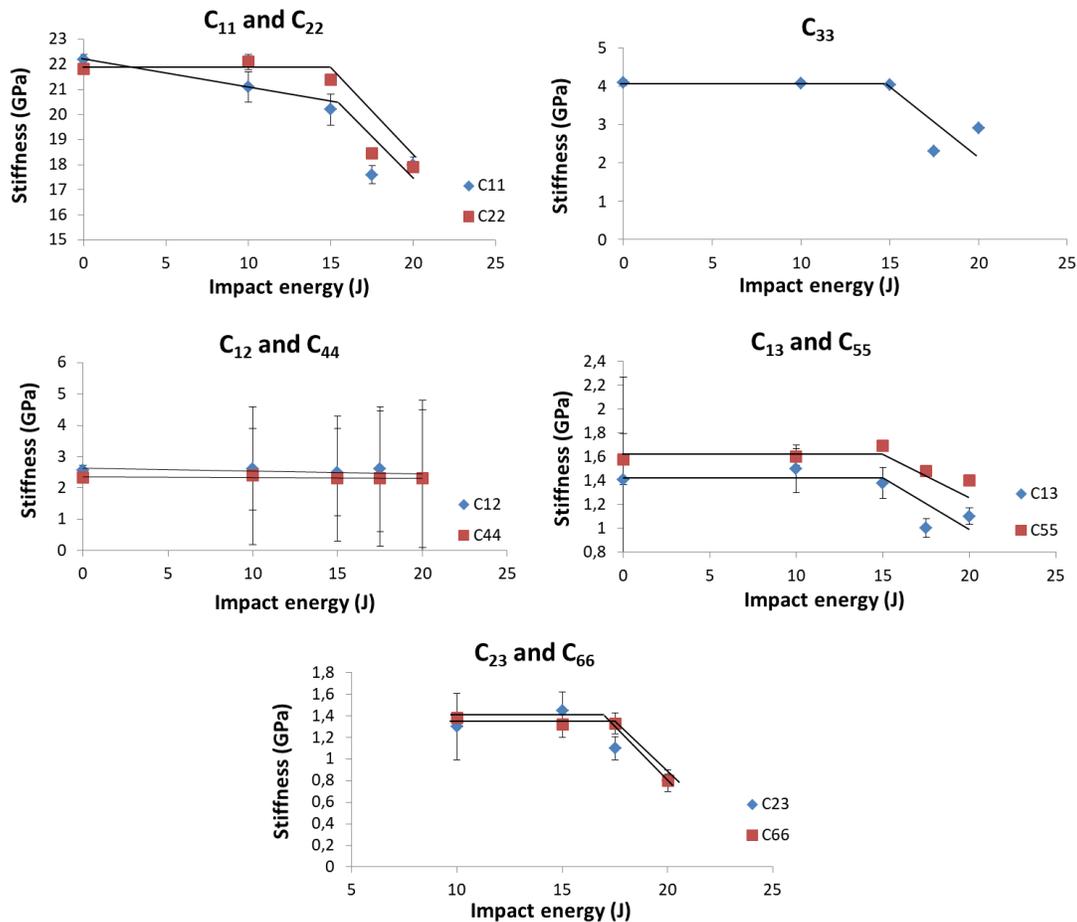
Figure 167 : Evolution of the nine stiffness components of the tested composite material when increasing drop weight energy

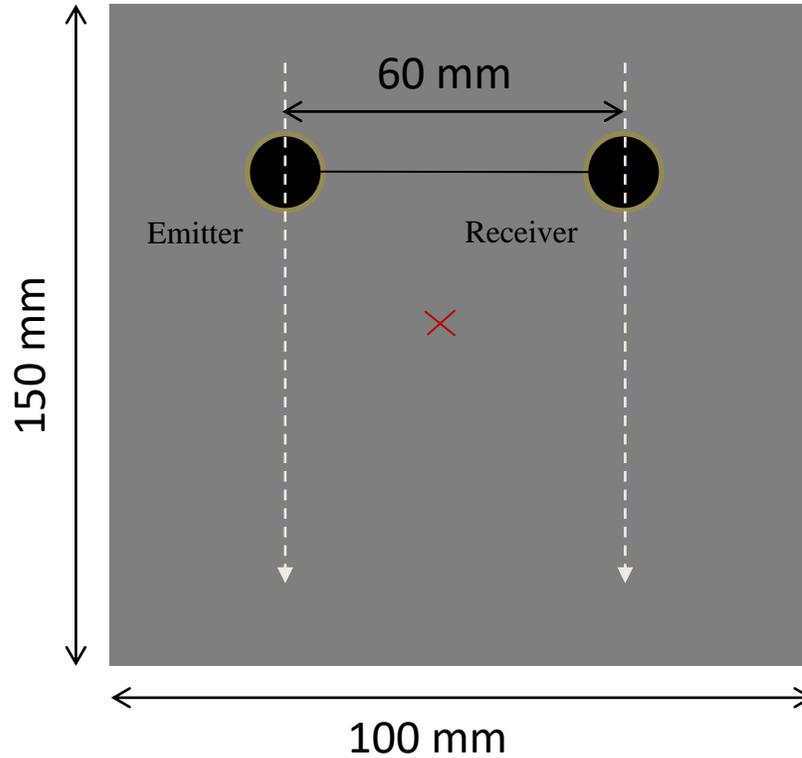
Figure 170 : Schematic representation of the experimental set-up for the guided waves investigations of the plate

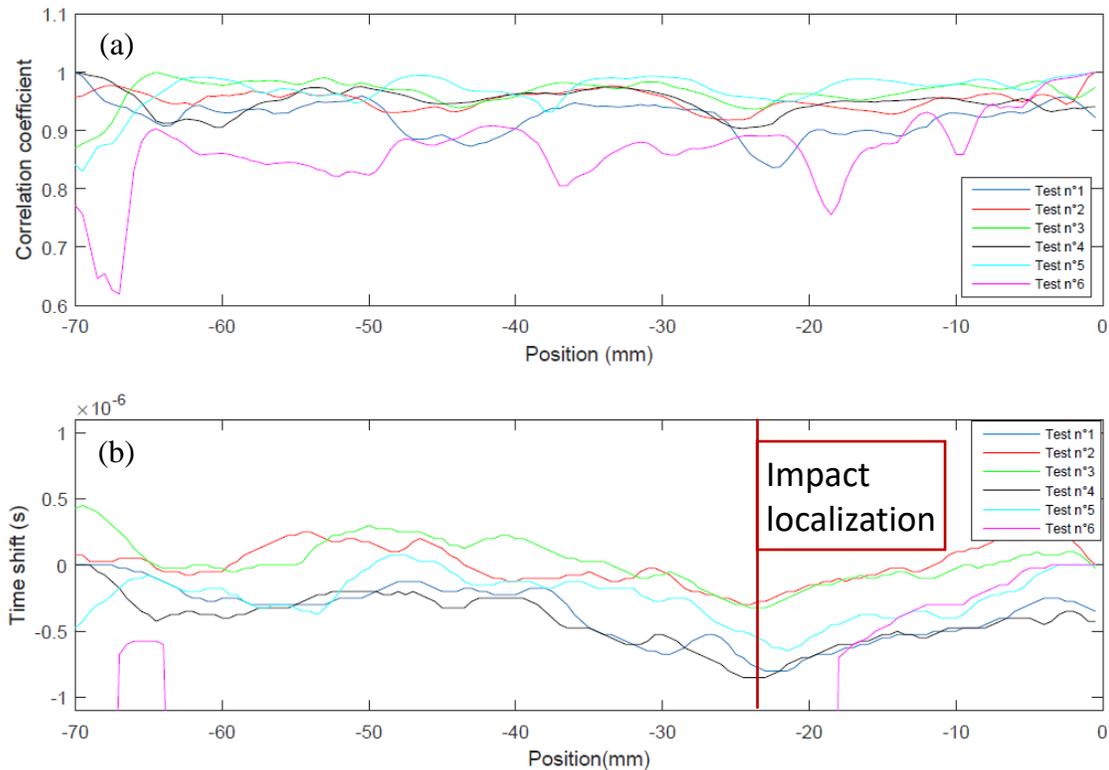
Figure 171 : (a) Evolution of the maximum correlation coefficient with the transducers position. (b) Evolution of the time lag with the transducers position

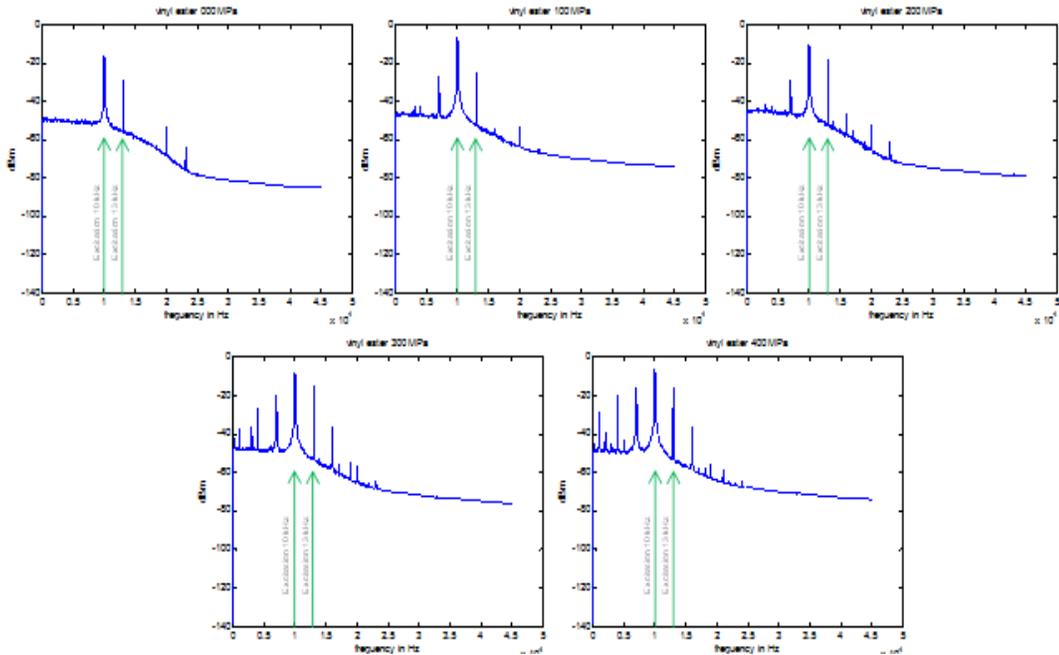
Figure 177 : Frequency response of the vinyl ester/glass composite submitted to different loading value. The input frequencies are indicate by the green arrow

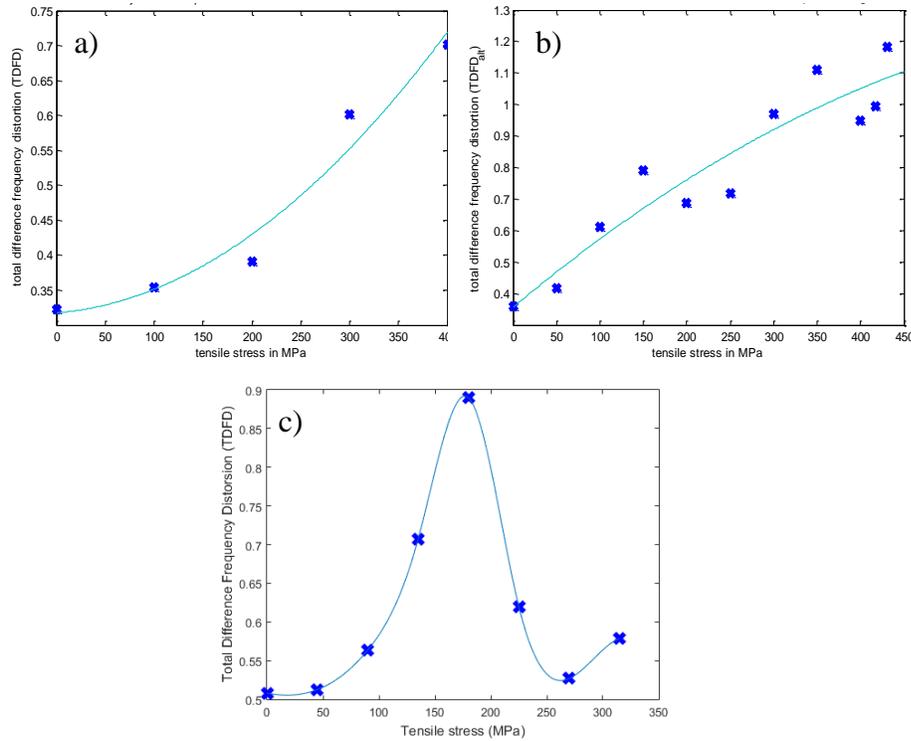
Figure 180 : TDFD parameter function of the loading value for a) Vinylester, b) epoxy and c) polyamide 6.6/6 matrix based woven glass fiber reinforced composites

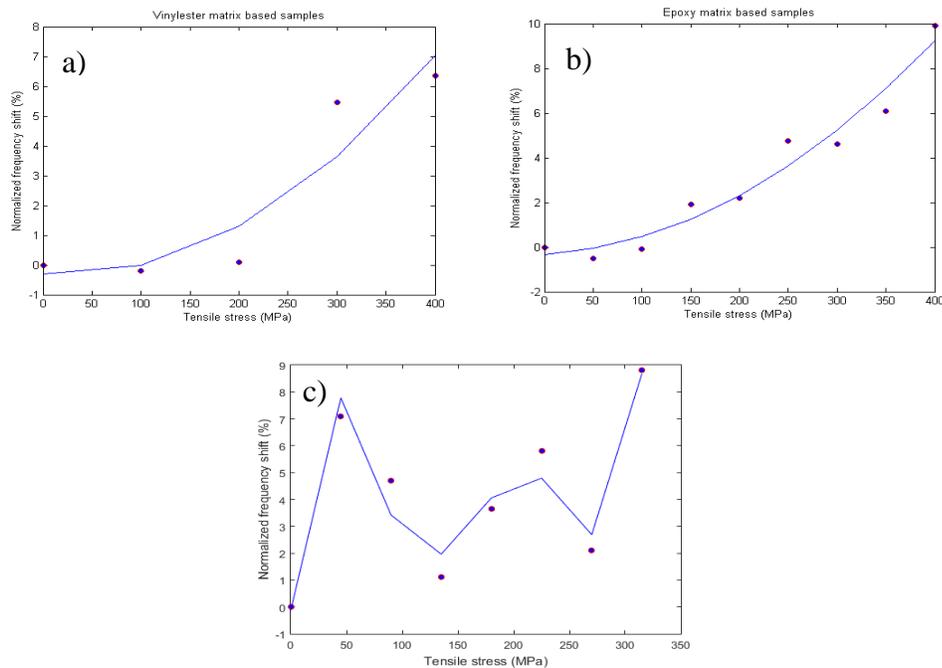
Figure 182 : Normalized frequency shift evolution function of the tensile loading level for the woven glass fiber reinforced and a) Vinylester based samples, b) Epoxy based samples, c) Polyamide 6.6/6 based samples

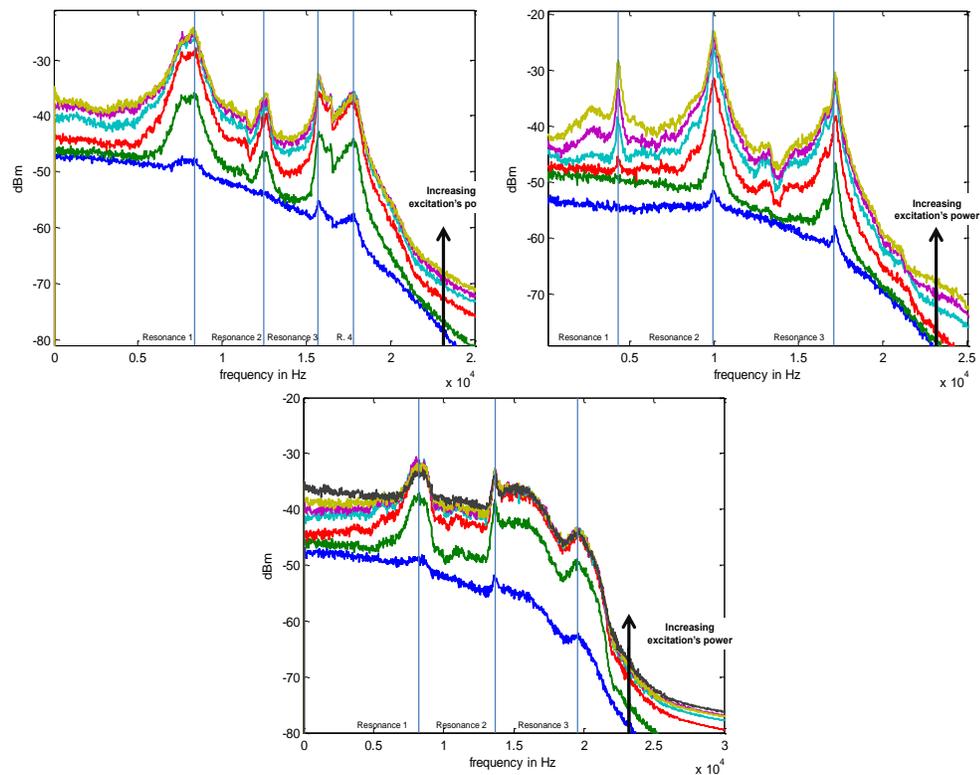
Figure 183 : Spectrum of the epoxy matrix sample damaged by a tensile stress of 400 MPa and excited by white noise under a stepwise increase of the excitation's power for the a) Vinylester samples, b) Epoxy samples, c) Polyamide 66 samples

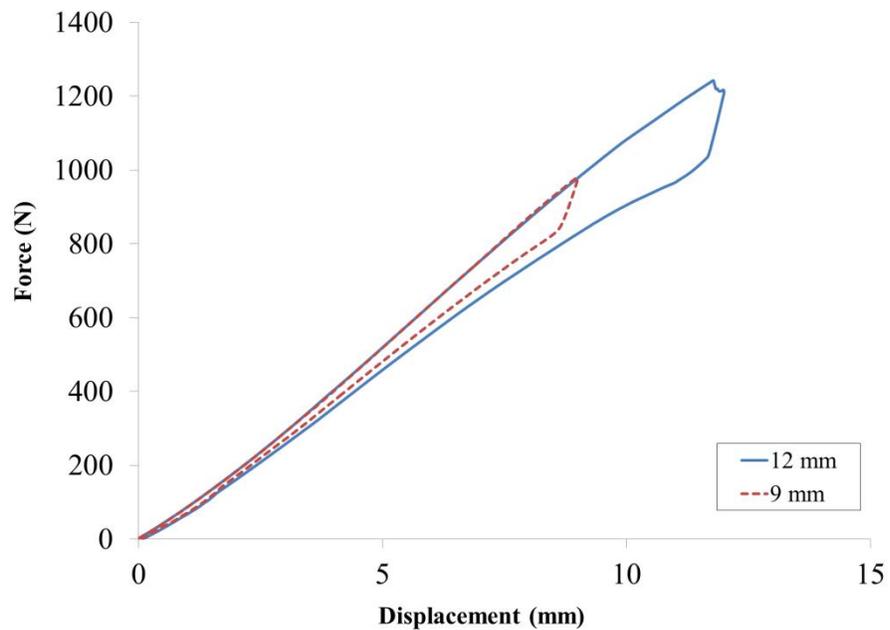
Figure 185 : Force displacement curve for the 12mm and 9mm four points bending tests

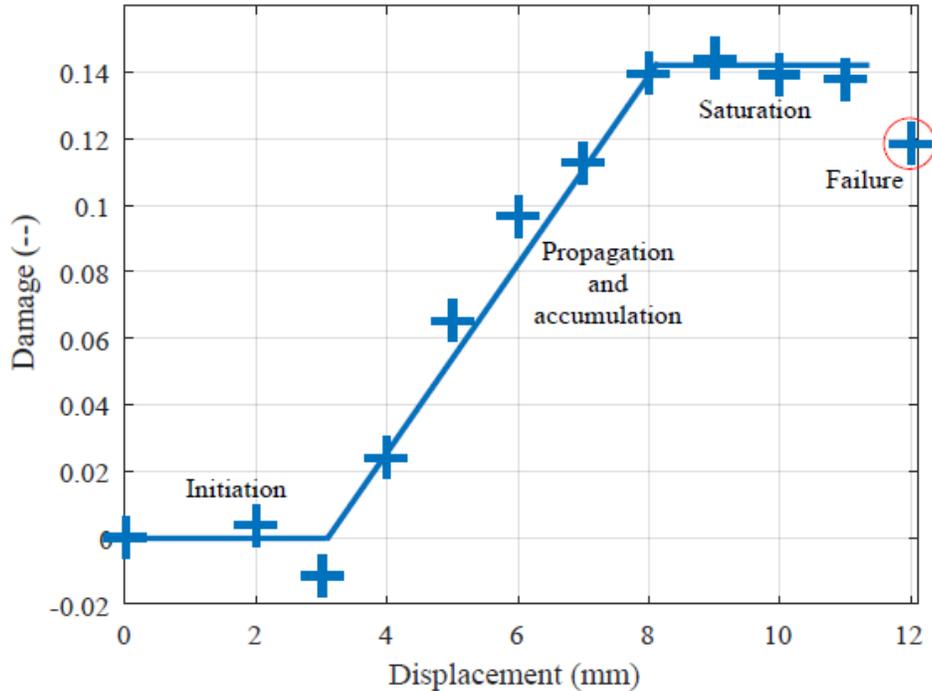
Figure 186 : Evolution of damage, calculated as the reduction of the bending modulus, with increasing the magnitude of the 4 points bending applied displacement

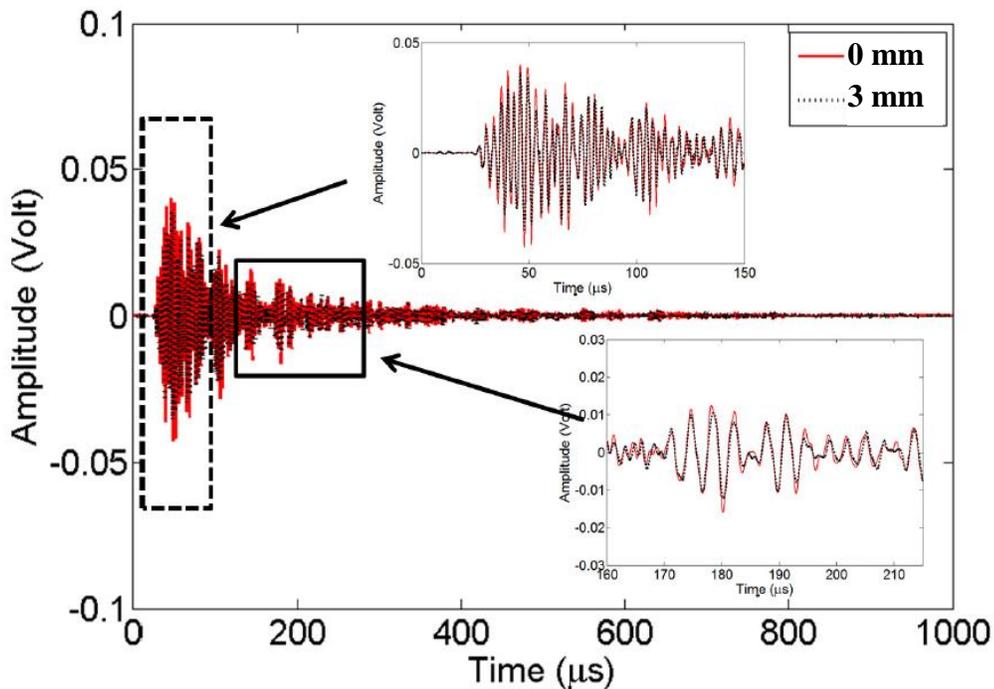
Figure 188 : Signal waveform recorded (in red continuous line) before any loading and (in dashed black line) after 3mm of four points bending applied

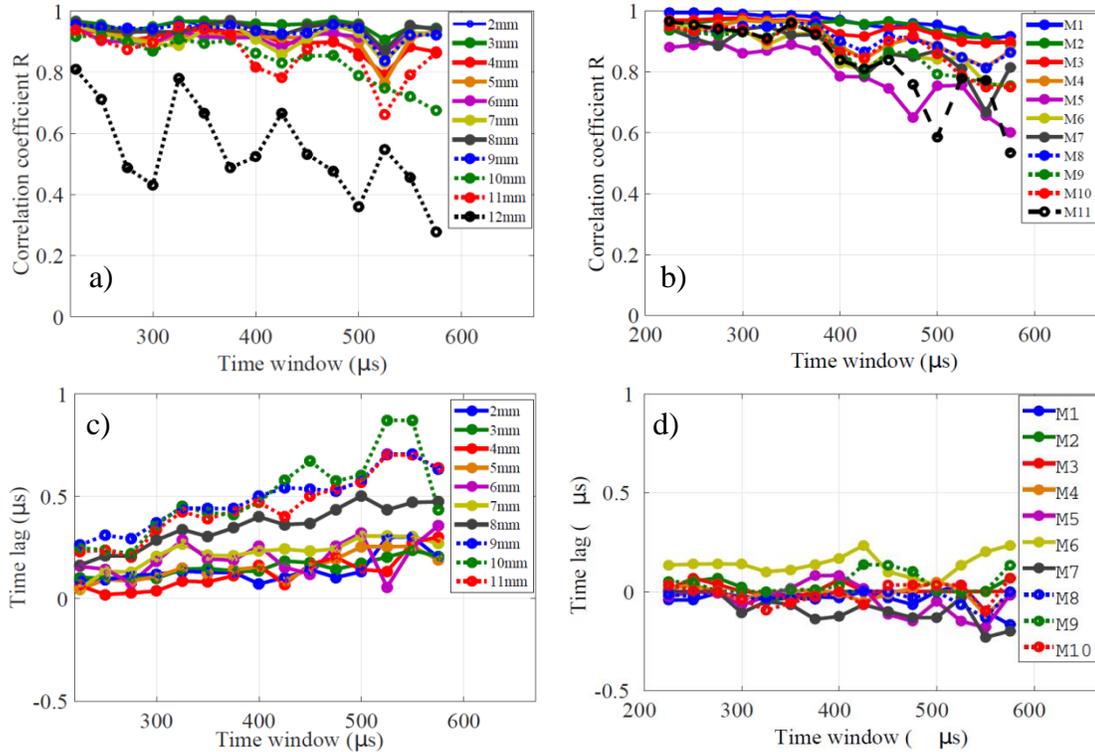
Figure 189 : a) Normalized cross-correlation coefficient between the sample loaded (200-1200N) and the sample before loading. b) Normalized cross-correlation coefficient for the reference sample between different moment and the first signal record for this sample. c) Time shift between the sample loaded (200-1200N) and the sample before loading. d) Time shift coefficient for the reference sample between different moment and the first signal record for this sample

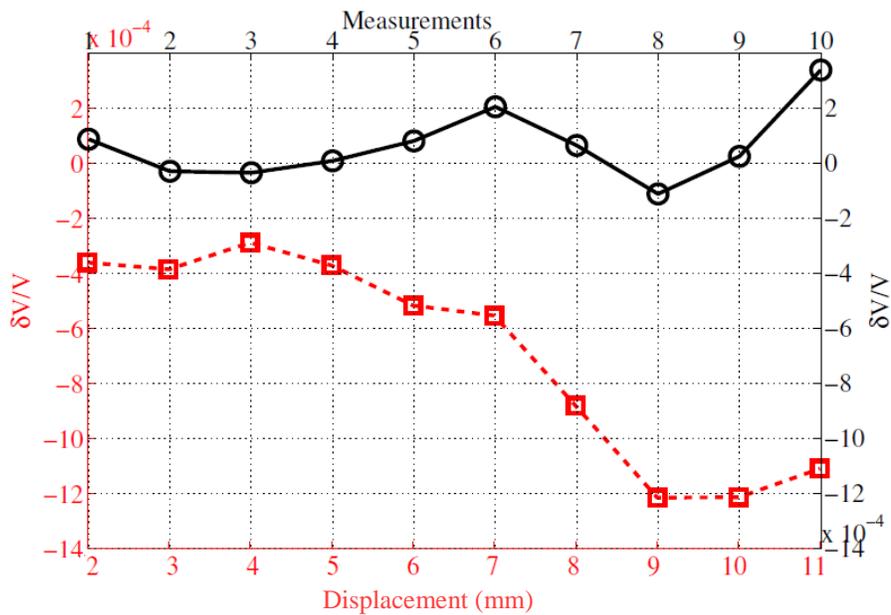
Figure 190 : Variation of $\delta V/V$ over the whole recorded signals for the sample 1 (in dashed red line) and the sample 2 (in continuous black line)
